LIEBHERR LH40M 146402-1215 - Diesel Engine

Sample No: LH0266027

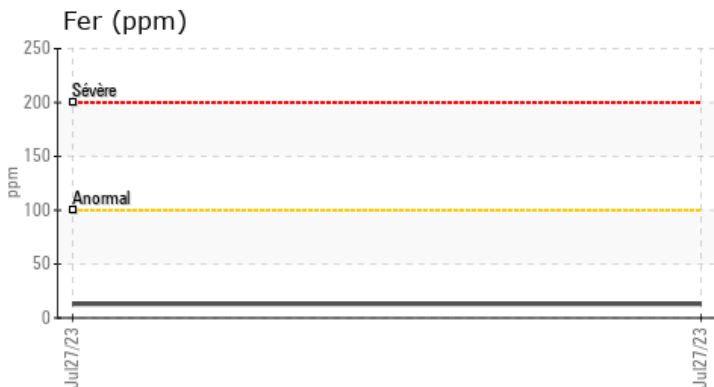
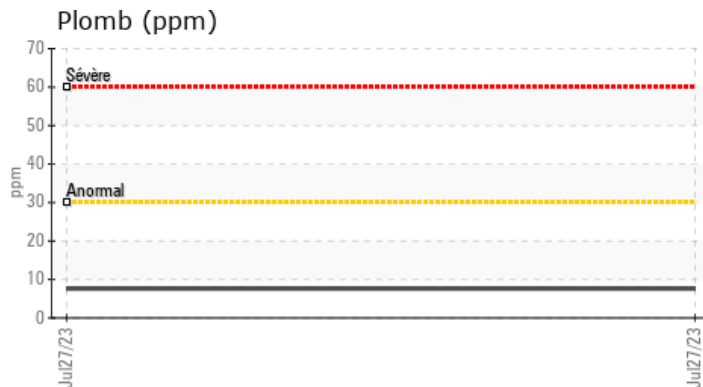
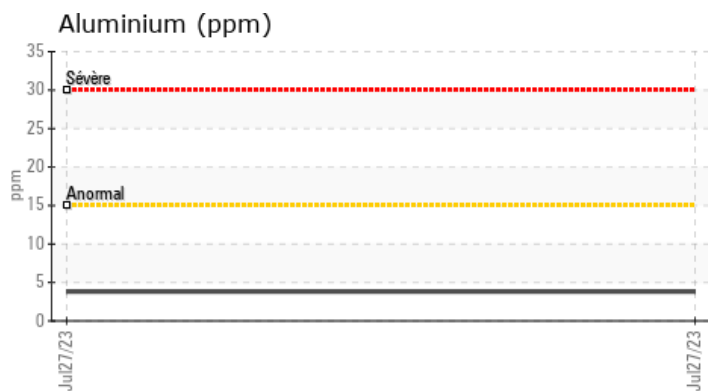
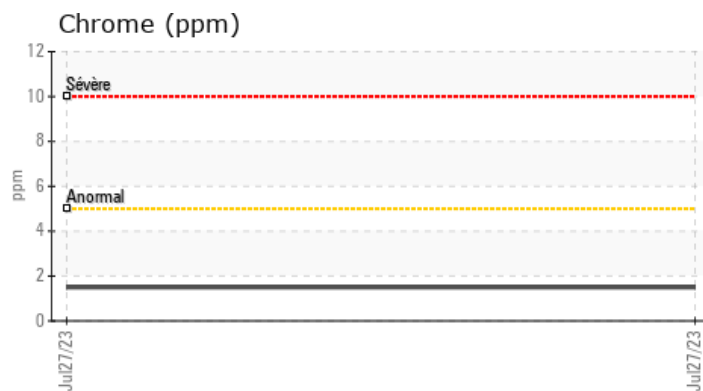
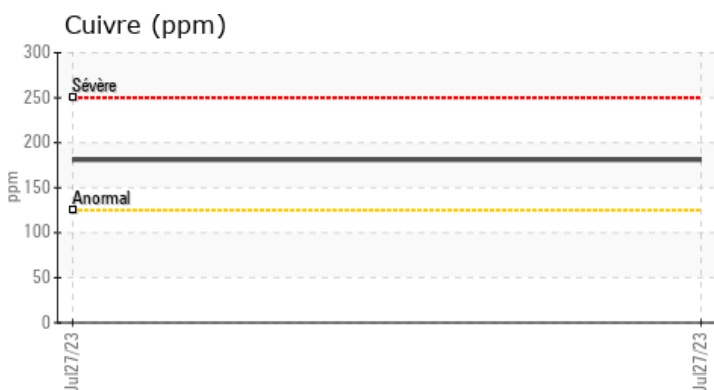
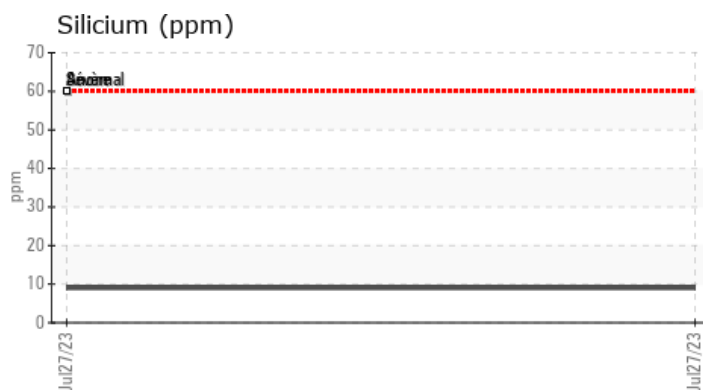
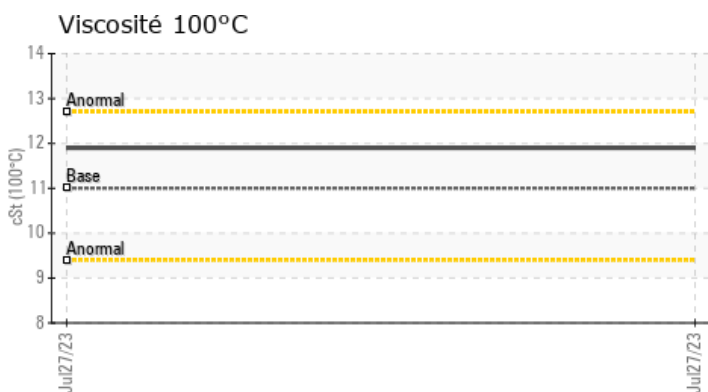
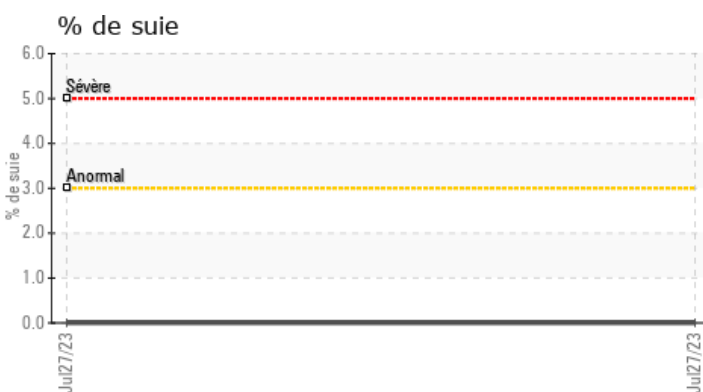
GRAPHS

Resample at the next service interval to monitor. Metal levels are typical for a new component breaking in. There is no indication of any contamination in the oil. The condition of the oil is acceptable for the time in service.
