# PROBLEM SUMMARY

Machine Id  
**2835**

Component  
**Hydraulic System**

# OIL ANALYSIS REPORT

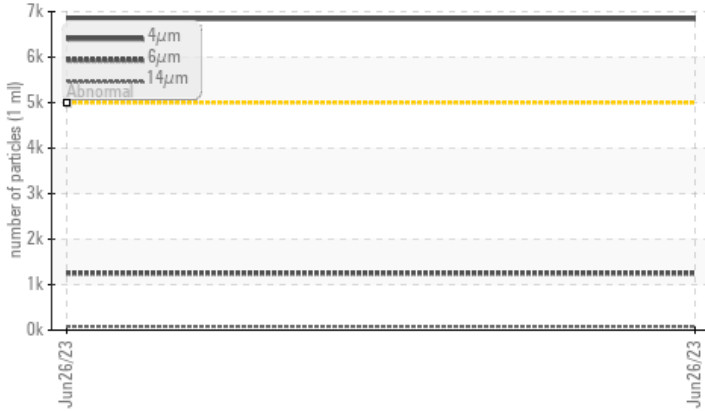
### ▲ Particle Trend

Sample Status	ATTENTION	---	---
Particles >4µm	ASTM D7647 >5000 ▲ <b>6844</b>	---	---
Oil Cleanliness	ISO 4406 (c) >19/17/14 ▲ <b>20/17/13</b>	---	---

There is a light amount of silt (particulates < 14 microns in size) present in the oil.

We recommend you service the filters on this component. Resample at the next service interval to monitor. NOTE: Please provide information regarding reservoir capacity, filter type and micron rating with next sample.

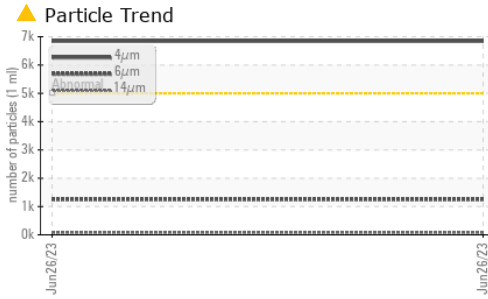
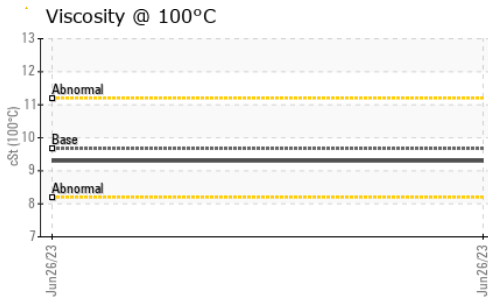
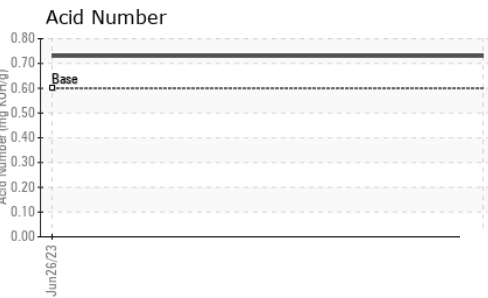
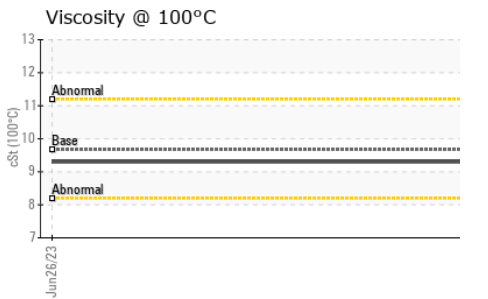
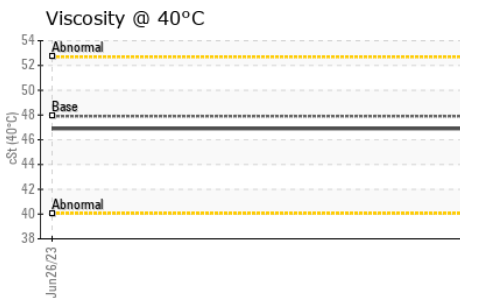
FLUID CLEANLINESS		method	limit/base	current	history 1	history 2
Particles >4µm		ASTM D7647	>5000	<b>▲ 6844</b>	---	---
Particles >6µm		ASTM D7647	>1300	<b>1253</b>	---	---
Particles >14µm		ASTM D7647	>160	<b>80</b>	---	---
Particles >21µm		ASTM D7647	>40	<b>20</b>	---	---
Particles >38µm		ASTM D7647	>10	<b>1</b>	---	---
Particles >71µm		ASTM D7647	>3	<b>0</b>	---	---
Oil Cleanliness		ISO 4406 (c)	>19/17/14	<b>▲ 20/17/13</b>	---	---

We recommend you service the filters on this component. Resample at the next service interval to monitor. NOTE: Please provide information regarding reservoir capacity, filter type and micron rating with next sample.
