OIL ANALYSIS REPORT

Area
GFL211/GfI217
 Machine Id
927065
 Component
Main Engine
 Fluid
NOT GIVEN (--- GAL)

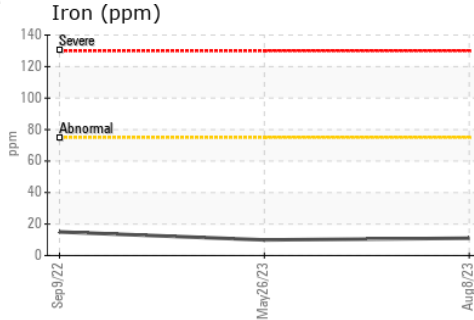
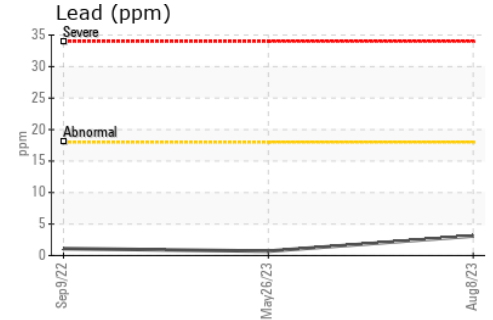
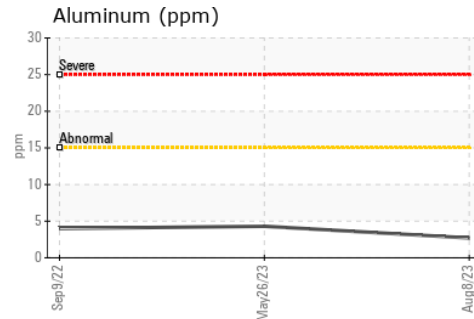
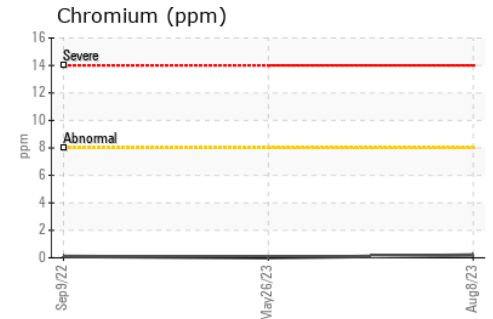
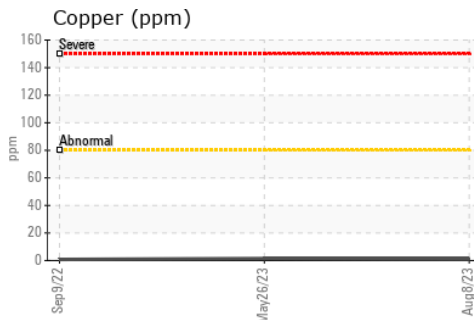
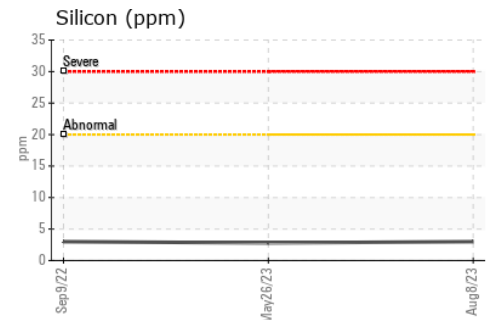
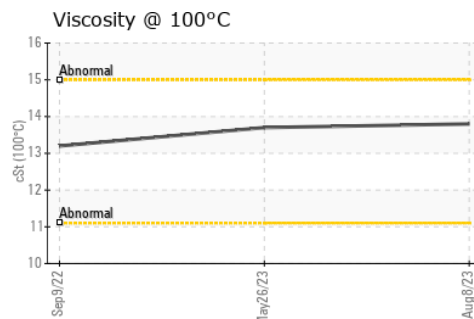
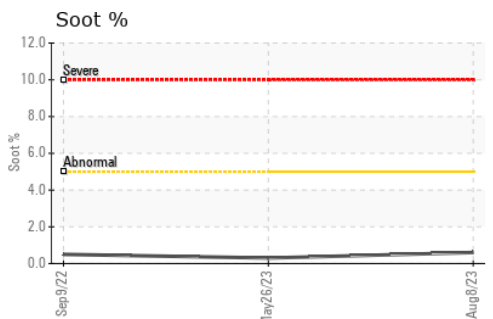
GRAPHS

All component wear rates are normal.

There is no indication of any contamination in the oil.

The condition of the oil is acceptable for the time in service.

Resample at the next service interval to monitor.
