PROBLEM SUMMARY

ENGEL #1

Hydraulic System

OIL ANALYSIS REPORT

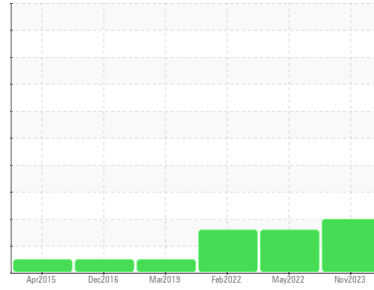
Sample Rating Trend

▲ Particle Trend

Sample Status			ATTENTION	ABNORMAL	ABNORMAL
Particles >4µm	ASTM D7647	>5000	▲ 6170	▲ 12630	4074
Particles >6µm	ASTM D7647	>1300	▲ 2023	▲ 3436	821
Particles >14µm	ASTM D7647	>160	▲ 206	▲ 240	51
Particles >21µm	ASTM D7647	>40	▲ 61	25	20
Oil Cleanliness	ISO 4406 (c)	>19/17/14	▲ 20/18/15	▲ 21/19/15	19/17/13

We recommend you service the filters on this component. Resample at the next service interval to monitor. Please specify the component make and model with your next sample. Please specify the brand, type, and viscosity of the oil on your next sample.

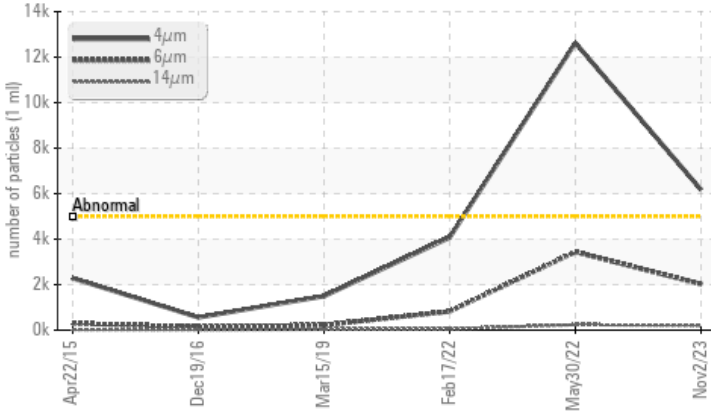
There is a light amount of silt (particulates < 14 microns in size) present in the oil.

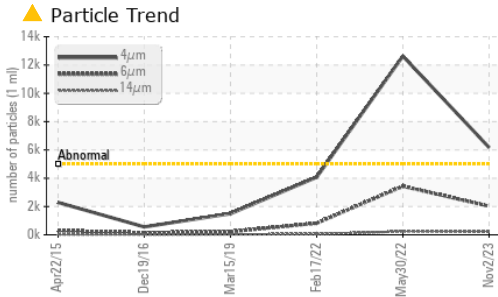
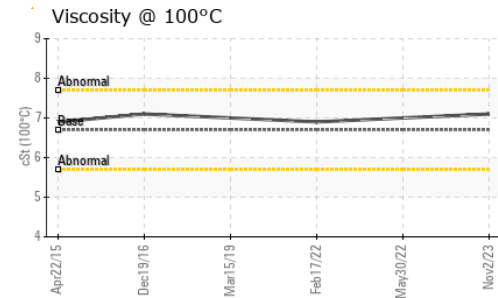
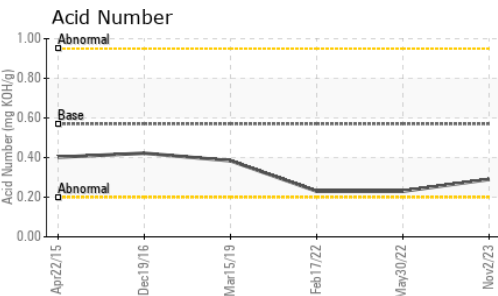
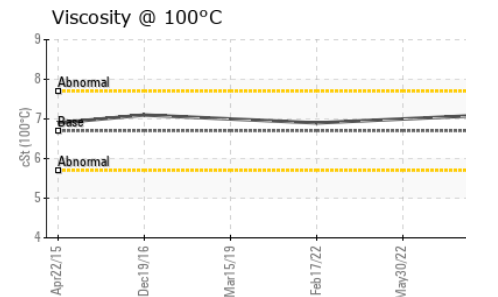
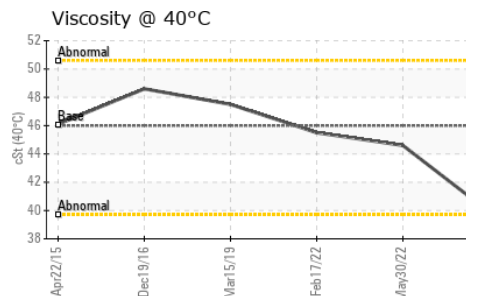
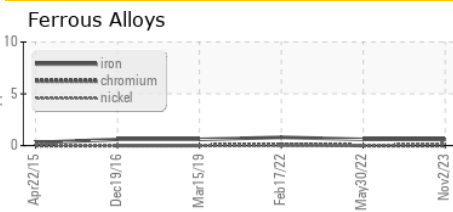
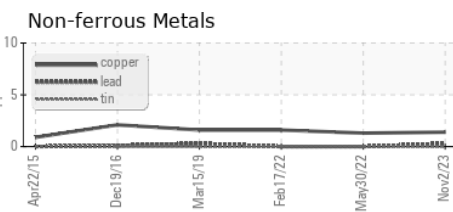
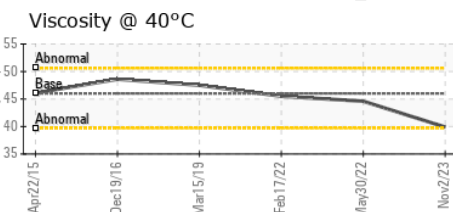
GRAPHS

FLUID CLEANLINESS		method	limit/base	current	history1	history2
Particles >4µm		ASTM D7647	>5000	▲ 6170	▲ 12630	4074
Particles >6µm		ASTM D7647	>1300	▲ 2023	▲ 3436	821
Particles >14µm		ASTM D7647	>160	▲ 206	▲ 240	51
Particles >21µm		ASTM D7647	>40	▲ 61	25	20
Particles >38µm		ASTM D7647	>10	7	1	3
Particles >71µm		ASTM D7647	>3	1	0	0
Oil Cleanliness		ISO 4406 (c)	>19/17/14	▲ 20/18/15	▲ 21/19/15	19/17/13

We recommend you service the filters on this component. Resample at the next service interval to monitor. Please specify the component make and model with your next sample. Please specify the brand, type, and viscosity of the oil on your next sample.

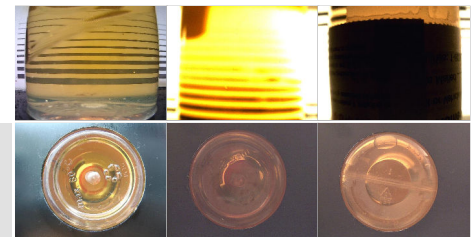
SAMPLE IMAGES	method	limit/base	current	history1	history2
---------------	--------	------------	---------	----------	----------

VISUAL	method	limit/base	current	history1	history2
White Metal	scalar	Visual*	NONE	NONE	NONE
Yellow Metal	scalar	Visual*	NONE	NONE	NONE
Precipitate	scalar	Visual*	NONE	NONE	VLITE
Silt	scalar	Visual*	NONE	NONE	NONE
Debris	scalar	Visual*	NONE	VLITE	VLITE
Sand/Dirt	scalar	Visual*	NONE	NONE	NONE
Appearance	scalar	Visual*	NORML	NORML	NORML
Odor	scalar	Visual*	NORML	NORML	NORML
Emulsified Water	scalar	Visual*	>0.1	NEG	NEG
Free Water	scalar	Visual*		NEG	▲ 1%
