Machine Id  
**NO UNIT PC0052542**  
Component  
**Gearbox**  
Fluid  
**SAE 80W90 (--- GAL)**

**Customer Id:** LABSTJ  
**Sample No.:** PC0052542  
**Lab Number:** 02599540  
**Test Package:** IND 2

# OIL ANALYSIS REPORT

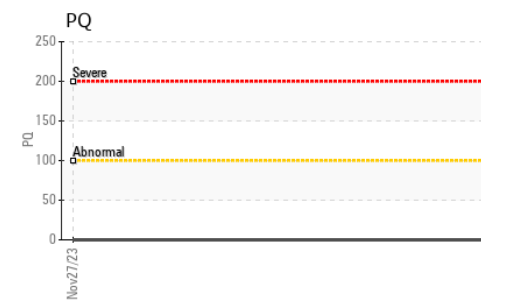
VISUAL	method	limit/base	current	history1	history2
White Metal	scalar	Visual*	NONE	NONE	---
Yellow Metal	scalar	Visual*	NONE	NONE	---
Precipitate	scalar	Visual*	NONE	NONE	---
Silt	scalar	Visual*	NONE	NONE	---
Debris	scalar	Visual*	NONE	NONE	---
Sand/Dirt	scalar	Visual*	NONE	NONE	---
Appearance	scalar	Visual*	NORML	▲ LAYRD	---
Odor	scalar	Visual*	NORML	NORML	---
Emulsified Water	scalar	Visual*	>0.2	▲ .5%	---
Free Water	scalar	Visual*		▲ 5%	---

Action	Status	Date	Done By	Description
Change Fluid	---	---	?	We recommend that you drain the oil from the component if this has not already been done.
Resample	---	---	?	We recommend an early resample to monitor this condition.
Alert	---	---	?	Little or no information is provided as to the component and lubricant being tested. Recommendations are therefore generic in nature and may not apply to the current application. Please forward information as to equipment type, reservoir capacity, lubricant type and any pertinent information to allow for a more accurate assessment.
Information Required	---	---	?	Please specify the brand, type, and viscosity of the oil on your next sample. NOTE: Please provide information regarding reservoir capacity, filter type and micron rating with next sample.
Check Water Access	---	---	?	We advise that you check for the source of water entry.
Check Seals	---	---	?	Check seals and/or filters for points of contaminant entry.

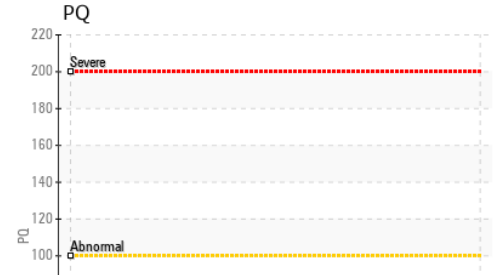
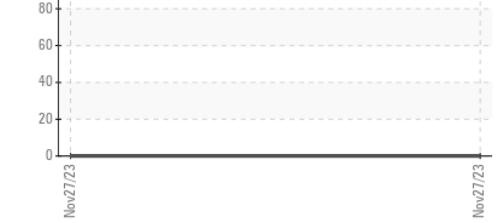
## GRAPHS

method	limit/base	current	history1	history2
Silicon	ppm ASTM D5185(m) >50	<b>2</b>	---	---
Sodium	ppm ASTM D5185(m) >50	<b>2</b>	---	---
Potassium	ppm ASTM D5185(m) >20	<b>&lt;1</b>	---	---
Water	% ASTM D6304* >0.2	<b>1.322</b>	---	---
ppm Water	ppm ASTM D6304* >2000	<b>13229</b>	---	---
