OIL ANALYSIS REPORT

Machine Id
CAL002

Component
Hydraulic System

Fluid
MOBIL DTE 10 EXCEL 32 (600 LTR)

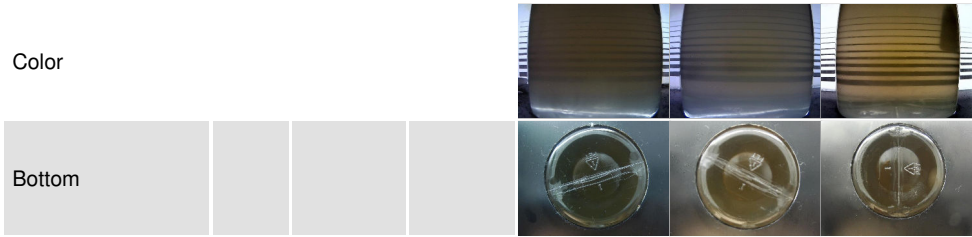
SAMPLE IMAGES

| VISUAL | method | limit/base | current | history1 | history2 |
|---|---|---|---|---|---|
| Appearance | scalar | Visual* | NORML | NORML | NORML |
| Odor | scalar | Visual* | NORML | NORML | NORML |
