# COOLANT REPORT

**Laboratory** : WearCheck - C8-1175 Appleby Line, Burlington, ON L7L 5H9    **GFL Environmental - 743 - Montreal Est CD Processing**  
**Sample No.** : GFL0067520    **Received** : 28 Feb 2024    10930 rue Sherbrooke  
**Lab Number** : 02618748    **Tested** : 28 Feb 2024    Montreal, QC  
**Unique Number** : 5735858    **Diagnosed** : 05 Mar 2024 - Kevin Marson    CA H1B 1B4  
**Test Package** : COOL ( Additional Tests: GlycolType )    Contact: Patrick Beaulieu  
patrick.beaulieu@gflenv.com

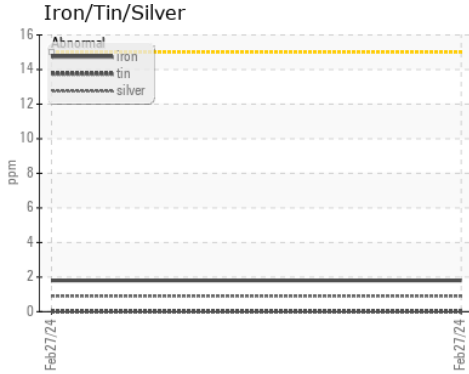
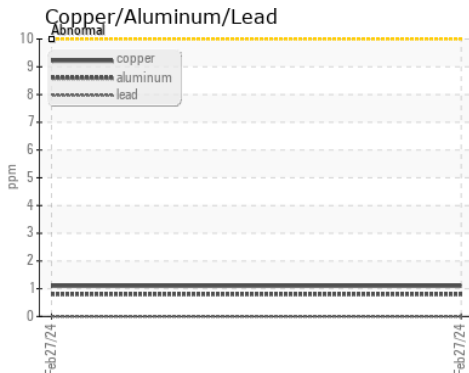
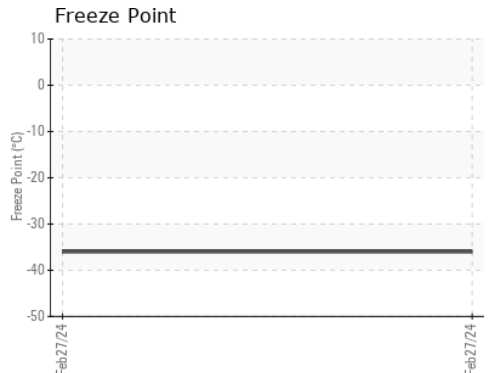
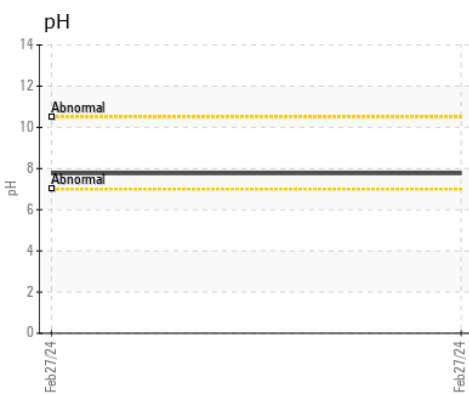
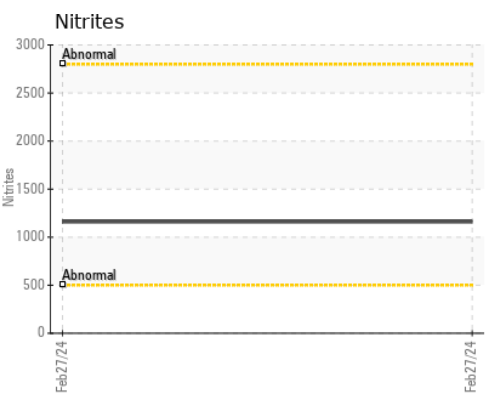
## GRAPHS

VISUAL	method	limit/base	current	history1	history2
Coolant Color	Visual*		<b>Grn/Yellow</b>	---	---
Coolant Appearance	Visual*	Clear	<b>▲ Cloudy</b>	---	---
Color
