# OIL ANALYSIS REPORT

**812052**

**Hydraulic System**

**PETRO CANADA HYDREX MV 32 (--- GAL)**

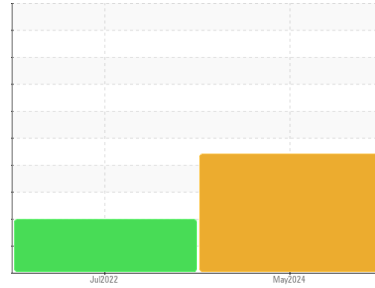
## Sample Rating Trend

Il y a une quantité élevée de matières particulaires (2 à 100 µm de taille) présente dans l'huile.

method	limit/base	current	history1	history2
Particles >4µm	ASTM D7647	>5000	<b>▲ 48915</b>	▲ 11926	---
Particles >6µm	ASTM D7647	>1300	<b>▲ 11699</b>	▲ 3332	---
Particles >14µm	ASTM D7647	>160	<b>▲ 652</b>	● 245	---
Particles >21µm	ASTM D7647	>40	<b>▲ 130</b>	● 57	---
Particles >38µm	ASTM D7647	>10	<b>5</b>	5	---
Particles >71µm	ASTM D7647	>3	<b>1</b>	1	---
Oil Cleanliness	ISO 4406 (c)	>19/17/14	<b>▲ 23/21/17</b>	▲ 21/19/15	---

Nous vous recommandons de vérifier tous les endroits par lesquels des contaminants peuvent pénétrer dans le système. Nous vous recommandons de remplacer le filtre et d'utiliser un système de filtrage hors-ligne afin d'améliorer la propreté du fluide. Le reniflard d'air doit être réparé. S'il n'est pas classé, nous vous recommandons de le remplacer par un reniflard à air adapté au micron et / ou au dessiccant. Si évalué, nous vous recommandons de réparer / remplacer le reniflard. Échantillonner de nouveau dans 30 à 45 jours afin de contrôler la situation.
