# OIL ANALYSIS REPORT

Machine Id  
**7233**  
Component  
**Hydraulic System**  
Fluid  
**PETRO CANADA HYDREX MV 32 (--- GAL)**

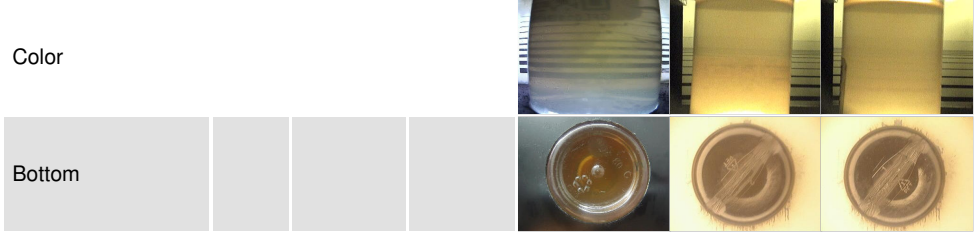
SAMPLE IMAGES	method	limit/base	current	history1	history2
---------------	--------	------------	---------	----------	----------

VISUAL	method	limit/base	current	history1	history2
White Metal	scalar	Visual*	NONE	NONE	NONE
Yellow Metal	scalar	Visual*	NONE	NONE	NONE
Precipitate	scalar	Visual*	NONE	NONE	NONE
Silt	scalar	Visual*	NONE	NONE	NONE
Debris	scalar	Visual*	NONE	NONE	NONE
Sand/Dirt	scalar	Visual*	NONE	NONE	NONE
Appearance	scalar	Visual*	NORML	NORML	NORML
Odor	scalar	Visual*	NORML	NORML	NORML
Emulsified Water	scalar	Visual*	>0.1	NEG	NEG
Free Water	scalar	Visual*		NEG	NEG
