# OIL ANALYSIS REPORT

**V837200 STANDBY POWER GENERATION 600V PACKAGE**

**Lube System**

**MOBIL DTE OIL MEDIUM (113 LTR)**

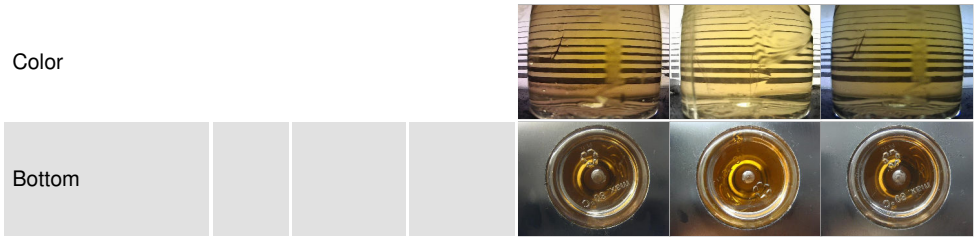
## SAMPLE IMAGES

VISUAL		method	limit/base	current	history1	history2
White Metal	scalar	Visual*	NONE	<b>VLITE</b>	NONE	NONE
Yellow Metal	scalar	Visual*	NONE	<b>NONE</b>	NONE	NONE
Precipitate	scalar	Visual*	NONE	<b>NONE</b>	NONE	NONE
Silt	scalar	Visual*	NONE	<b>NONE</b>	NONE	NONE
Debris	scalar	Visual*	NONE	<b>NONE</b>	NONE	NONE
Sand/Dirt	scalar	Visual*	NONE	<b>NONE</b>	NONE	NONE
Appearance	scalar	Visual*	NORML	<b>NORML</b>	NORML	NORML
Odor	scalar	Visual*	NORML	<b>NORML</b>	NORML	NORML
Emulsified Water	scalar	Visual*	>0.05	<b>NEG</b>	NEG	NEG
Free Water	scalar	Visual*		<b>NEG</b>	NEG	NEG
