OIL ANALYSIS REPORT

Laboratory : WearCheck - C8-1175 Appleby Line, Burlington, ON L7L 5H9
Sample No. : GFL0123451
Lab Number : 02648367
Unique Number : 5813919
Test Package : MOB 1 (Additional Tests: Visual)

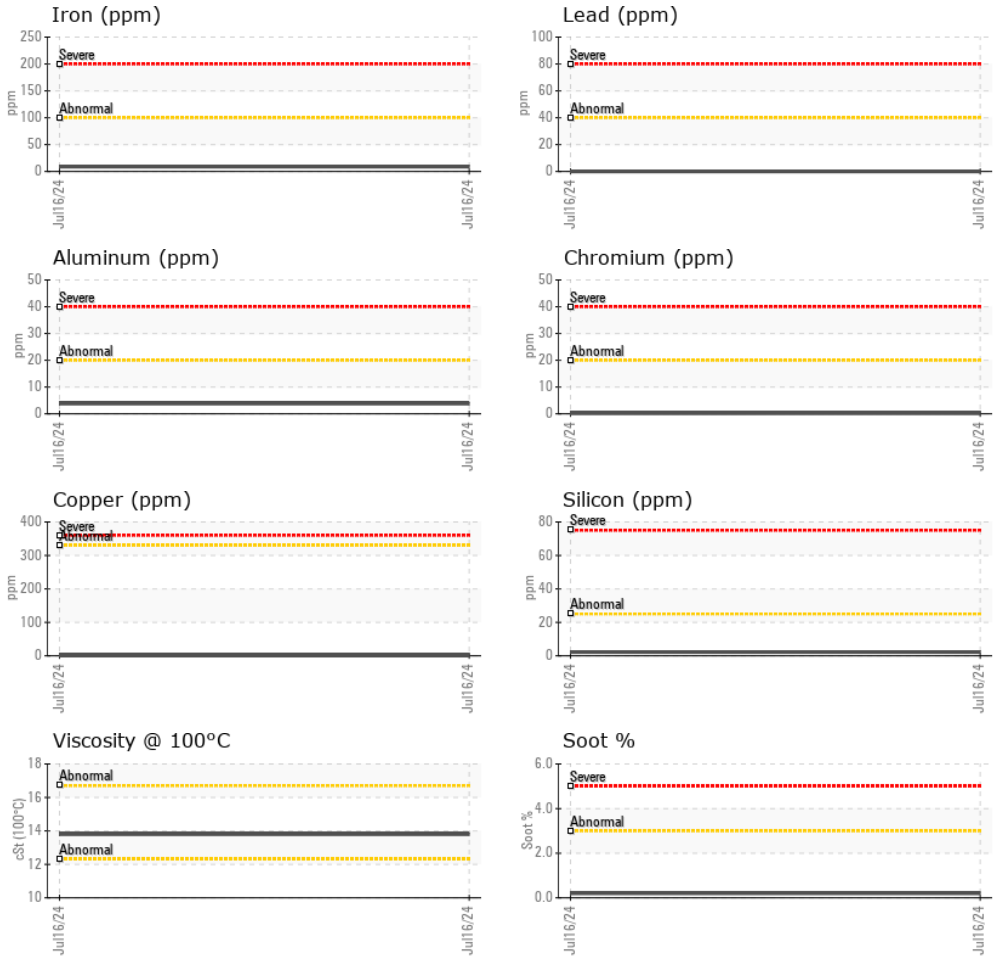
GRAPHS

FLUID DEGRADATION		method	limit/base	current	history1	history2
Oxidation	Abs./1mm	ASTM D7414*	>25	16.3	---	---

FLUID PROPERTIES		method	limit/base	current	history1	history2
Visc @ 100°C	cSt	ASTM D7279(m)		13.8	---	---
