OIL ANALYSIS REPORT

Area
KEMP QUARRIES / PRYOR STONE
 Machine Id
WL077
 Component
Hydraulic System
 Fluid
MOBIL MOBILFLUID 424 (--- GAL)

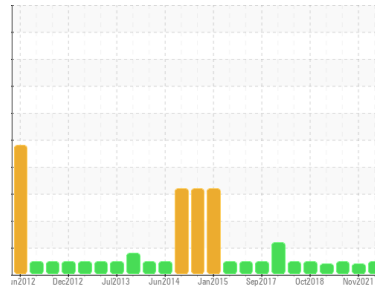
Sample Rating Trend

NORMAL

All component wear rates are normal.

There is no indication of any contamination in the oil.

The condition of the oil is acceptable for the time in service.

Resample at the next service interval to monitor. (Customer Sample Comment: Pm 2)
