OIL ANALYSIS REPORT

Area
KEMP QUARRIES / RIVER VALLEY ARKOMA
Machine Id
WL108
Component
Front Differential
Fluid
MOBIL MOBILTRANS HD 50 (--- GAL)

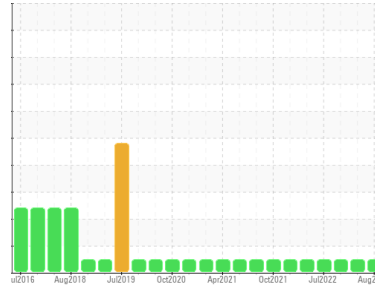
Sample Rating Trend

NORMAL

All component wear rates are normal.

There is no indication of any contamination in the oil.

The condition of the oil is acceptable for the time in service.

Resample at the next service interval to monitor.
