Machine Id
427190
 Component
2 Differential
 Fluid
GEAR OIL SAE 75W90 (--- GAL)

Customer Id: GFL983
 Sample No.: GFL0089384
 Lab Number: 05921864
 Test Package: FLEET

OIL ANALYSIS REPORT

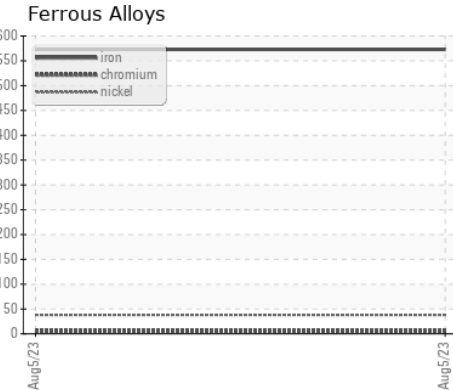
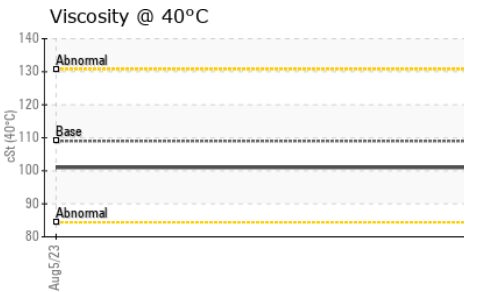
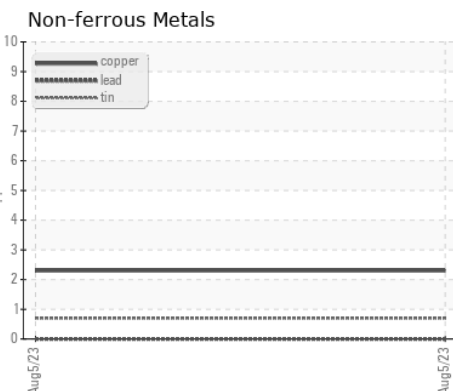
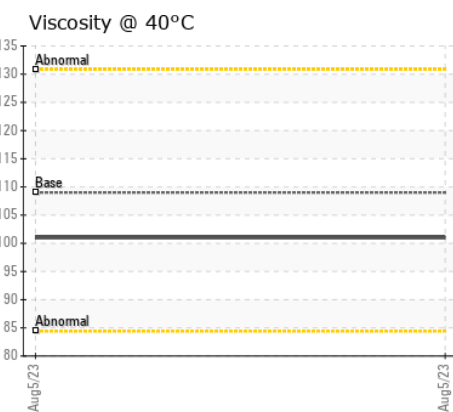
GRAPHS

method	limit/base	current	history1	history2
Iron ppm ASTM D5185m	>500	573	---	---
Chromium ppm ASTM D5185m	>10	5	---	---
Nickel ppm ASTM D5185m	>10	38	---	---
Titanium ppm ASTM D5185m		<1	---	---
Silver ppm ASTM D5185m		0	---	---
Aluminum ppm ASTM D5185m	>25	▲ 14	---	---
Lead ppm ASTM D5185m	>25	0	---	---
Copper ppm ASTM D5185m	>100	2	---	---
Tin ppm ASTM D5185m	>10	<1	---	---
Vanadium ppm ASTM D5185m		<1	---	---
Cadmium ppm ASTM D5185m		<1	---	---

method	limit/base	current	history1	history2
Silicon ppm ASTM D5185m	>75	▲ 206	---	---
Sodium ppm ASTM D5185m		7	---	---
Potassium ppm ASTM D5185m	>20	7	---	---
