Machine Id
North Big Ridge 1

Component
Compressor

Fluid
PETRO CANADA TURBOFLO R&O 150 (--- GAL)

OIL ANALYSIS REPORT

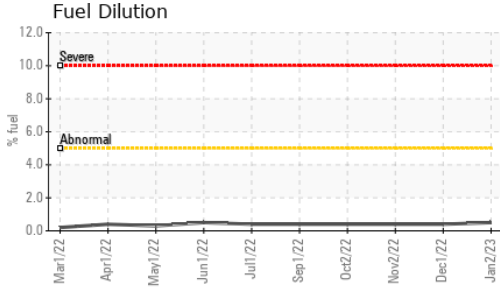
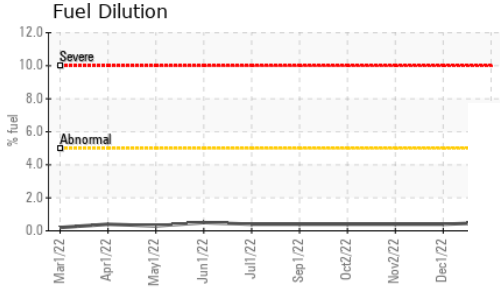
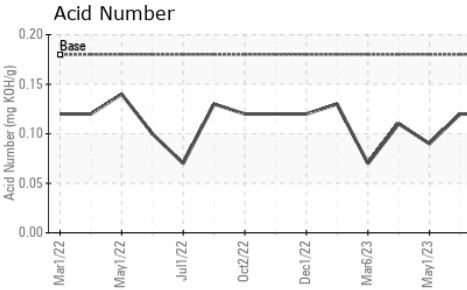
- Recommendation**
Resample at the next service interval to monitor.
- Wear**
All component wear rates are normal.
- Contamination**
There is no indication of any contamination in the oil.
- Fluid Condition**
The AN level is acceptable for this fluid. The condition of the oil is suitable for further service.
