# PROBLEM SUMMARY

Area  
**[98375876]**  
 Machine Id  
**KR-GR-001078 - 650 LB MIXER (S/N KOSHER SPICE - 11513205)**  
 Component  
**Gearbox**  
 Fluid  
**GEAR OIL ISO 220 (--- QTS)**

# OIL ANALYSIS REPORT

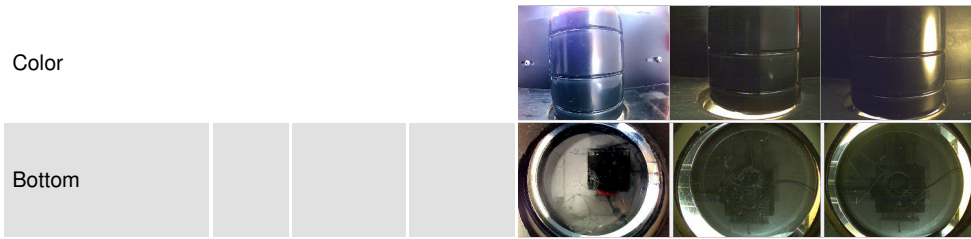
SAMPLE IMAGES	method	limit/base	current	history1	history2
---------------	--------	------------	---------	----------	----------

VISUAL	method	limit/base	current	history1	history2	
White Metal	scalar	*Visual	NONE	<b>LIGHT</b>	MODER	MODER
Yellow Metal	scalar	*Visual	NONE	<b>NONE</b>	NONE	NONE
Precipitate	scalar	*Visual	NONE	<b>NONE</b>	NONE	NONE
Silt	scalar	*Visual	NONE	<b>NONE</b>	NONE	NONE
Debris	scalar	*Visual	NONE	<b>NONE</b>	NONE	NONE
Sand/Dirt	scalar	*Visual	NONE	<b>NONE</b>	NONE	NONE
Appearance	scalar	*Visual	NORML	<b>NORML</b>	NORML	NORML
Odor	scalar	*Visual	NORML	<b>NORML</b>	NORML	NORML
Emulsified Water	scalar	*Visual	>0.2	<b>NEG</b>	NEG	NEG
Free Water	scalar	*Visual		<b>NEG</b>	NEG	NEG
