PROBLEM SUMMARY

Machine Id
433003
 Component
Front Natural Gas Engine
 Fluid
15W40 CNG (--- LTR)

Customer Id: GFL836
 Sample No.: GFL0090636
 Lab Number: 05930615
 Test Package: FLEET

OIL ANALYSIS REPORT

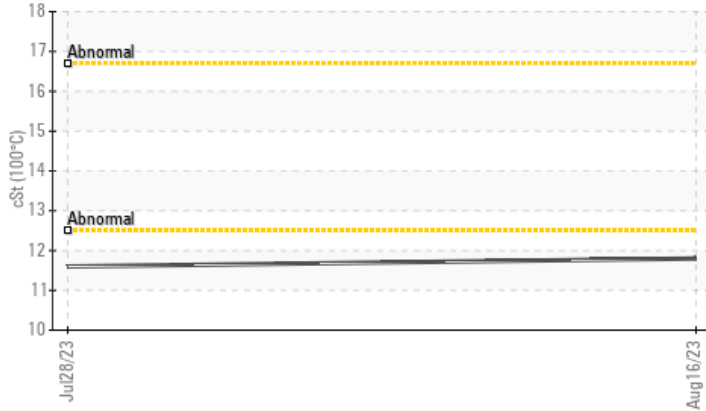
VISCOSITY

▲ Viscosity @ 100°C

Sample Status			ATTENTION	NORMAL	---
Visc @ 100°C	cSt	ASTM D445	▲ 11.8	11.6	---

The oil viscosity is lower than normal. The BN result indicates that there is suitable alkalinity remaining in the oil. Confirm oil type.

No corrective action is recommended at this time.
 Resample at the next service interval to monitor.
