OIL ANALYSIS REPORT

Machine Id
slider press Crowncork seal
 Component
Circulating System
 Fluid
PETRO CANADA PURITY FG WHITE OIL 15 (--- GAL)

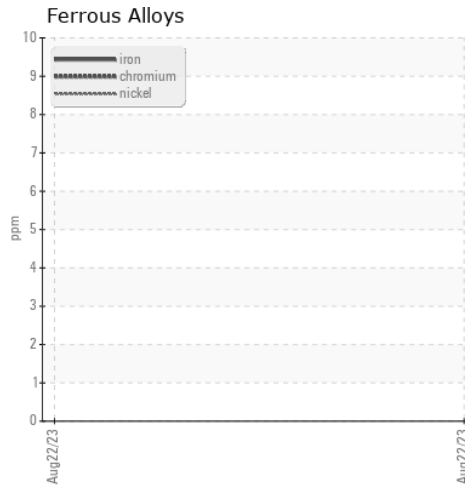
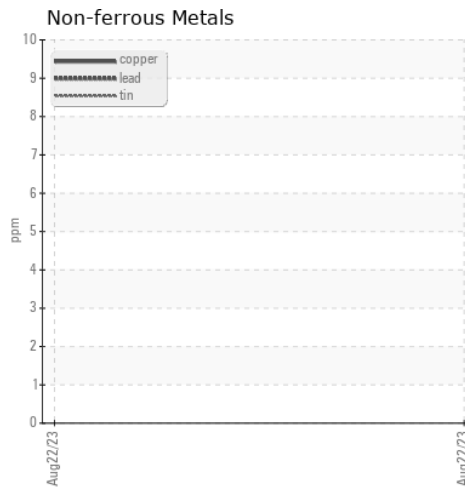
GRAPHS

Debris appears to be metal shavings and organic material similar to wax. Suspect build up is accumulation of metal particles from the manufacturing process combined with the oil protectant. Debris is highly magnetic and partially flammable.
