PROBLEM SUMMARY

OIL ANALYSIS REPORT

Machine Id
427191
 Component
2 Differential
 Fluid
NOT GIVEN (--- GAL)

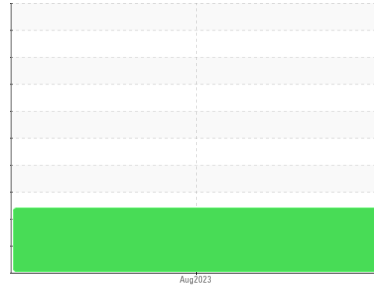
Sample Rating Trend

Sample Status				ABNORMAL	---	---
Aluminum	ppm	ASTM D5185m	>25	▲ 11	---	---
Silicon	ppm	ASTM D5185m	>75	▲ 235	---	---

We advise that you check all areas where dirt can enter the system. The oil change at the time of sampling has been noted. Resample at the next service interval to monitor. (Customer Sample Comment: 2nd Axle / Tag)

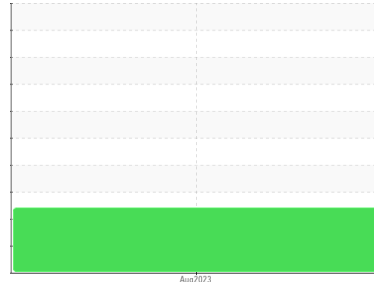
Sample Rating Trend

All component wear rates are normal.

Elemental levels of silicon (Si) and aluminum (Al) indicate alumina-silicate (coarse dirt) ingress.

The condition of the oil is acceptable for the time in service.

We advise that you check all areas where dirt can enter the system. The oil change at the time of sampling has been noted. Resample at the next service interval to monitor. (Customer Sample Comment: 2nd Axle / Tag)

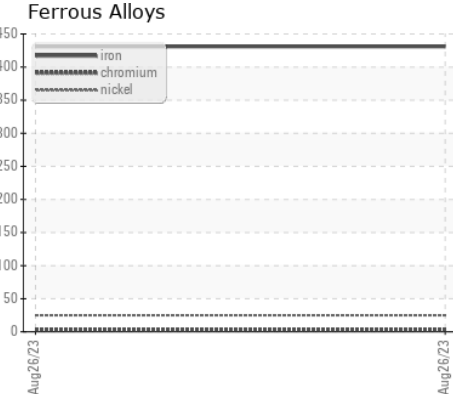
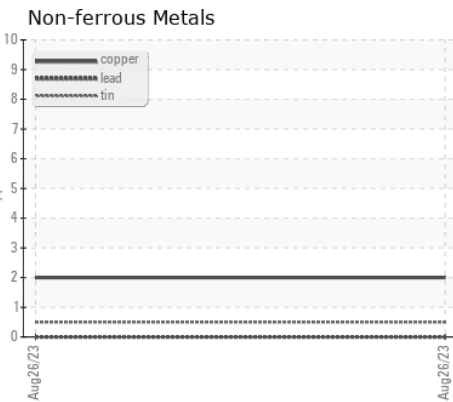
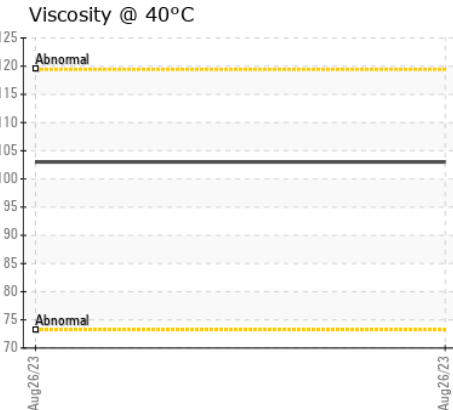
GRAPHS

method	limit/base	current	history1	history2
Silicon ppm	ASTM D5185m >75	▲ 235	---	---
Sodium ppm	ASTM D5185m	3	---	---
Potassium ppm	ASTM D5185m >20	6	---	---
