PROBLEM SUMMARY

Area
[98403568]
 Machine Id
CELL 3 AUGER CART
 Component
Gearbox
 Fluid
MOBIL SHC CIBUS 460 (--- QTS)

OIL ANALYSIS REPORT

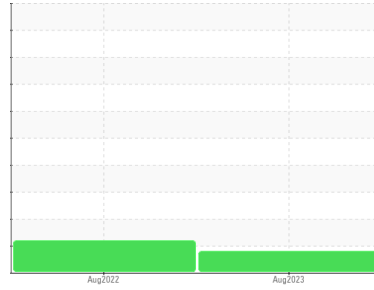
Sample Rating Trend

▲ Particle Trend

Sample Status		ABNORMAL	ABNORMAL	---
Particles >4µm	ASTM D7647 >10000	▲ 28358	▲ 185535	---
Oil Cleanliness	ISO 4406 (c) >20/18/16	▲ 22/16/12	▲ 25/22/15	---

We recommend you service the filters on this component if applicable. Resample at the next service interval to monitor.

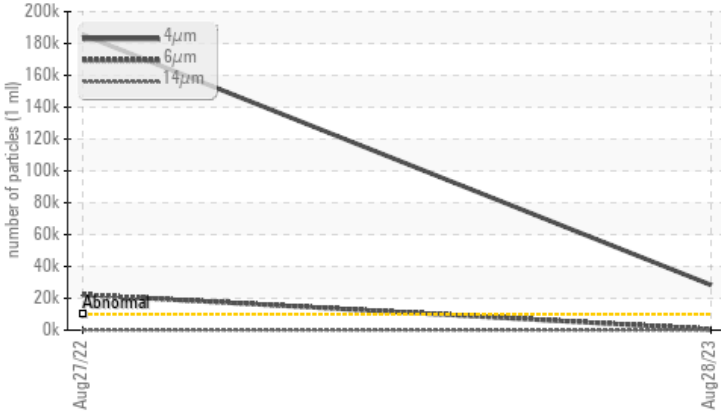
There is a high amount of silt (particulates < 14 microns in size) present in the oil.

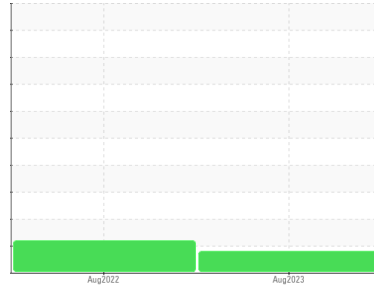
Sample Rating Trend

The AN level is acceptable for this fluid. The condition of the oil is suitable for further service.

We recommend you service the filters on this component if applicable. Resample at the next service interval to monitor.
