OIL ANALYSIS REPORT

Area
KEMP QUARRIES / RIVER VALLEY ARKOMA
Machine Id
WL108
Component
Rear Left Final Drive
Fluid
MOBIL MOBILTRANS HD 50 (--- GAL)

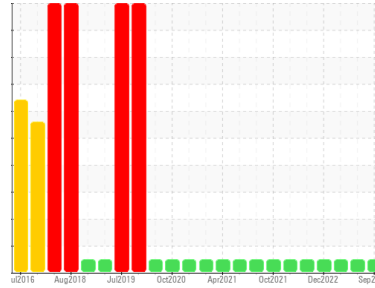
Sample Rating Trend

NORMAL

All component wear rates are normal.

There is no indication of any contamination in the oil.

The condition of the oil is acceptable for the time in service.

Resample at the next service interval to monitor.
