# PROBLEM SUMMARY

Machine Id  
**VOLVO VNL 26359 (S/N 4VHMC9EG8EH173850)**  
 Component  
**Rear Differential**  
 Fluid  
**NOT GIVEN (--- QTS)**

# OIL ANALYSIS REPORT

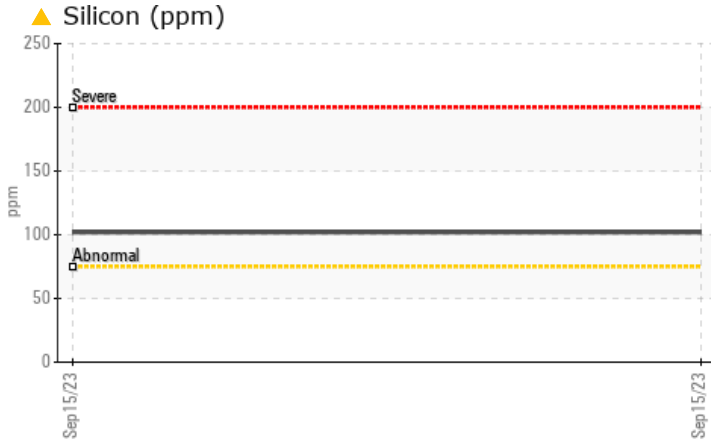
## COMPONENT CONDITION SUMMARY

Sample Status				<b>ABNORMAL</b>	---	---
Silicon	ppm	ASTM D5185m	>75	▲ 102	---	---

Elemental level of silicon (Si) above normal.

No corrective action is recommended at this time.  
 Resample at the next service interval to monitor.

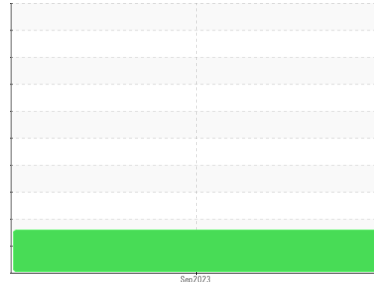
Sample Rating Trend

**DIRT**

No corrective action is recommended at this time. Resample at the next service interval to monitor.
