Machine Id
2126956
 Component
Rear Differential
 Fluid
VOLVO (--- QTS)

OIL ANALYSIS REPORT

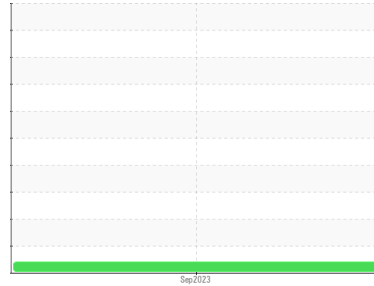
Sample Rating Trend

VIS DEBRIS

No corrective action is recommended at this time.
Resample at the next service interval to monitor.

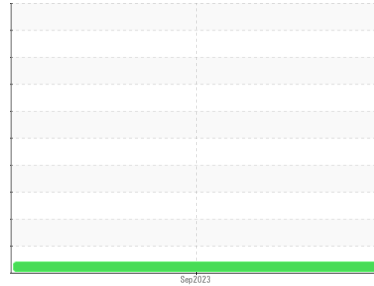
Sample Rating Trend

VIS DEBRIS

Moderate concentration of visible dirt/debris present in the oil.

No corrective action is recommended at this time. Resample at the next service interval to monitor.
