Machine Id
PRESS 2

Component
Hydraulic System

Fluid
PETRO CANADA HYDREX AW 46 (--- GAL)

OIL ANALYSIS REPORT

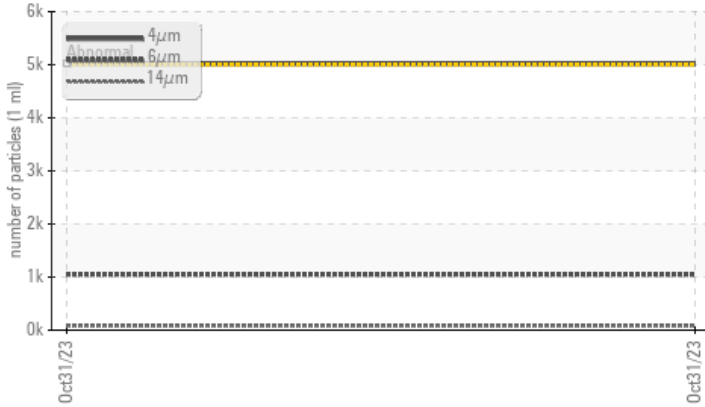
▲ Particle Trend

Sample Status			ATTENTION	---	---
Particles >4µm	ASTM D7647	>5000	▲ 5014	---	---
Oil Cleanliness	ISO 4406 (c)	>19/17/14	▲ 20/17/14	---	---

There is a moderate amount of silt (particulates < 6 microns in size) present in the oil.

No corrective action is recommended at this time.
Resample at the next service interval to monitor.

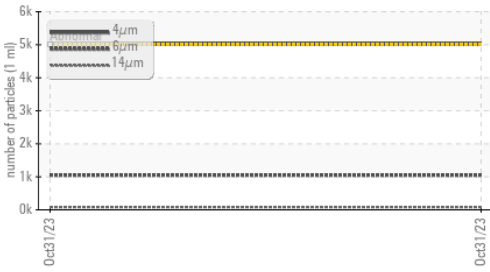
▲ Particle Trend

method	limit/base	current	history1	history2
Particles >4µm	ASTM D7647	>5000	▲ 5014	---
Particles >6µm	ASTM D7647	>1300	1051	---
Particles >14µm	ASTM D7647	>160	81	---
Particles >21µm	ASTM D7647	>40	19	---
Particles >38µm	ASTM D7647	>10	1	---
Particles >71µm	ASTM D7647	>3	0	---
Oil Cleanliness	ISO 4406 (c)	>19/17/14	▲ 20/17/14	---

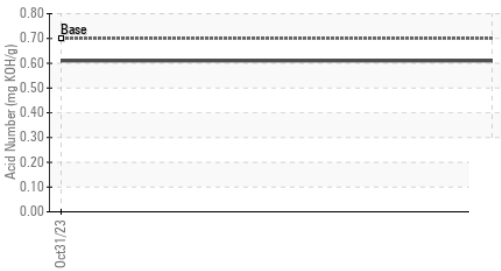
The AN level is acceptable for this fluid. The condition of the oil is acceptable for the time in service.

method	limit/base	current	history1	history2
Acid Number (AN)	mg KOH/g	ASTM D8045 0.70	0.61	---

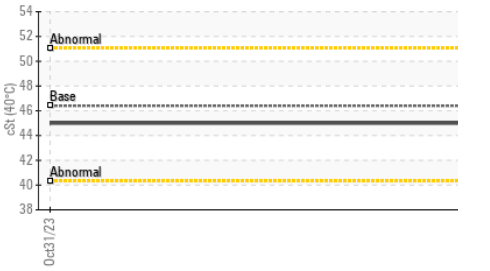
Viscosity @ 40°C

FLUID PROPERTIES	method	limit/base	current	history1	history2	
Visc @ 40°C	cSt	ASTM D445	46.4	45.0	---	---
