OIL ANALYSIS REPORT

Area
KEMP QUARRIES / HULBERT
Machine Id
WL131
Component
Front Right Final Drive
Fluid
MOBIL MOBILTRANS HD 50 (--- GAL)

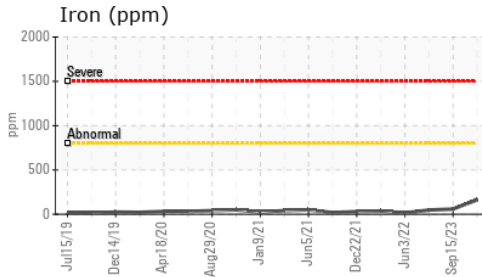
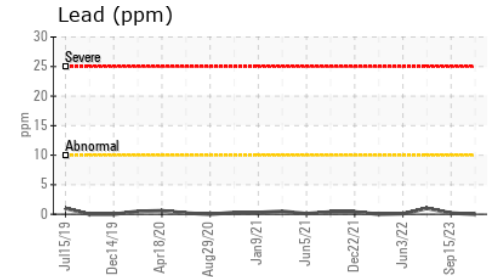
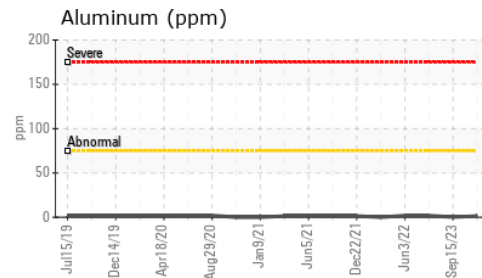
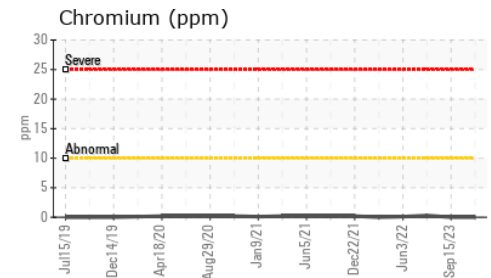
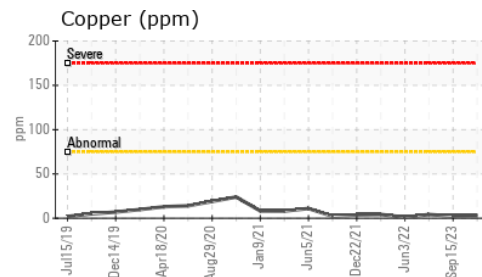
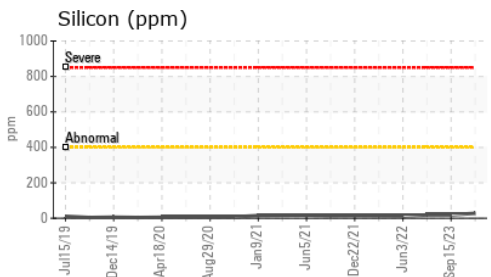
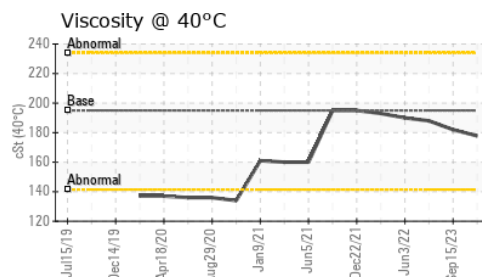
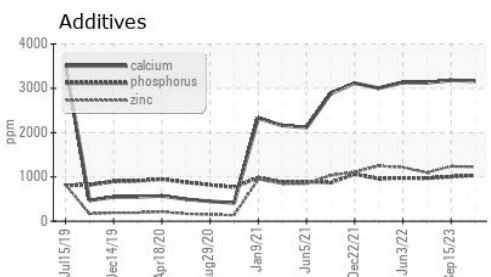
GRAPHS

All component wear rates are normal.

There is no indication of any contamination in the oil.

The condition of the oil is acceptable for the time in service.

Resample at the next service interval to monitor.
