PROBLEM SUMMARY

Machine Id
WL0089
 Component
Hydraulic System
 Fluid
NOT GIVEN (--- GAL)

OIL ANALYSIS REPORT

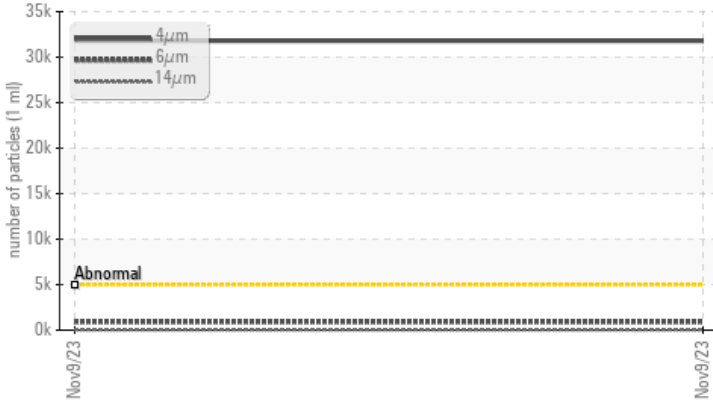
▲ Particle Trend

Sample Status			ABNORMAL	---	---
Particles >4µm	ASTM D7647	>5000	▲ 31788	---	---
Oil Cleanliness	ISO 4406 (c)	>19/17/14	▲ 22/17/13	---	---

The filter change at the time of sampling has been noted. We recommend an early resample to monitor this condition. Please specify the brand, type, and viscosity of the oil on your next sample.
