OIL ANALYSIS REPORT

Machine Id
Copperhead Gap 1

Component
Compressor

Fluid
PETRO CANADA TURBOFLO R&O 150 (--- GAL)

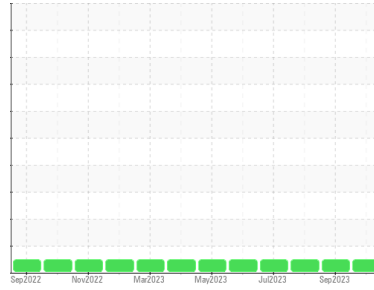
Sample Rating Trend

NORMAL

Resample at the next service interval to monitor.

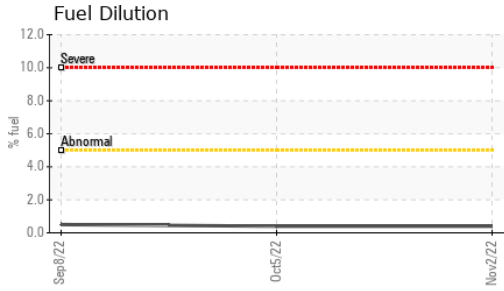
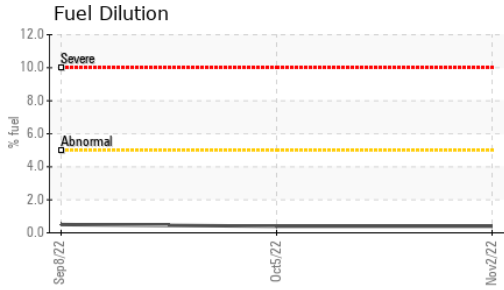
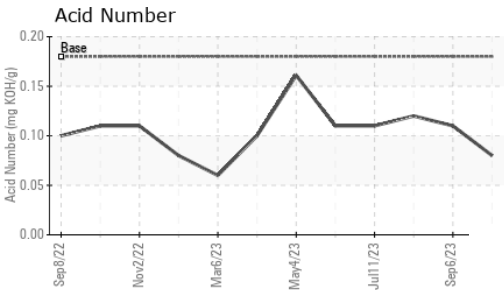
GRAPHS

All component wear rates are normal.

There is no indication of any contamination in the oil.

The AN level is acceptable for this fluid. The condition of the oil is suitable for further service.
