Machine Id
912066

Component
Hydraulic System

Fluid
PETRO CANADA ENVIRON MV 46 (--- GAL)

OIL ANALYSIS REPORT

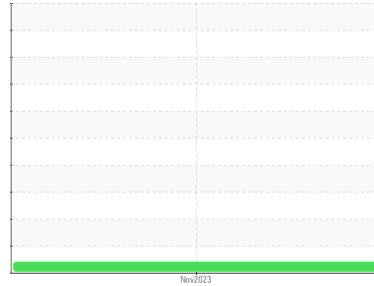
Sample Rating Trend

VIS DEBRIS

Sample Status				ABNORMAL	---	---
Debris	scalar	*Visual	NONE	▲ MODER	---	---

No corrective action is recommended at this time. The filter change at the time of sampling has been noted. Resample at the next service interval to monitor. We were unable to perform a particle count due to a high concentration of particles present in this sample.

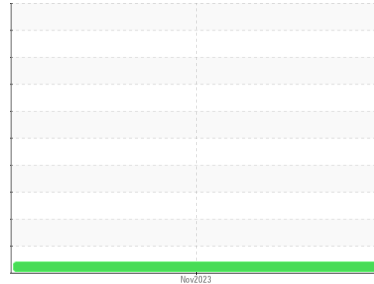
Sample Rating Trend

VIS DEBRIS

Moderate concentration of visible dirt/debris present in the oil.

No corrective action is recommended at this time. The filter change at the time of sampling has been noted. Resample at the next service interval to monitor. We were unable to perform a particle count due to a high concentration of particles present in this sample.

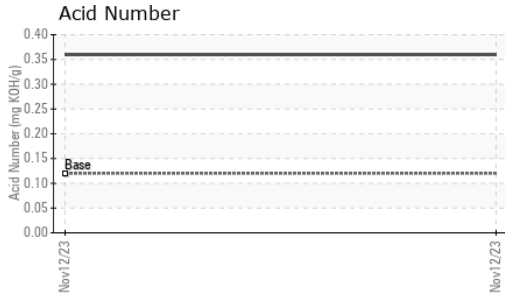
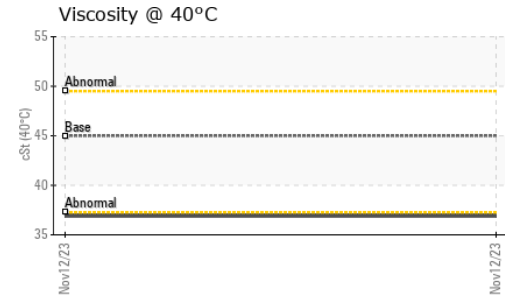
SAMPLE IMAGES

VISUAL	method	limit/base	current	history1	history2
White Metal	scalar	*Visual	NONE	NONE	---
Yellow Metal	scalar	*Visual	NONE	NONE	---
Precipitate	scalar	*Visual	NONE	NONE	---
Silt	scalar	*Visual	NONE	NONE	---
Debris	scalar	*Visual	NONE	▲ MODER	---
Sand/Dirt	scalar	*Visual	NONE	NONE	---
Appearance	scalar	*Visual	NORML	NORML	---
Odor	scalar	*Visual	NORML	NORML	---
Emulsified Water	scalar	*Visual	>0.1	NEG	---
Free Water	scalar	*Visual		NEG	---

method	limit/base	current	history1	history2
Color				no image	no image
Bottom				no image	no image
