OIL ANALYSIS REPORT

Area
Galv Line
 Machine Id
[Galv Line] 650250-HOT BRIDLE ROLL # 3
 Component
Gearbox
 Fluid
PETRO CANADA ENDURATEX EP 220 (--- GAL)

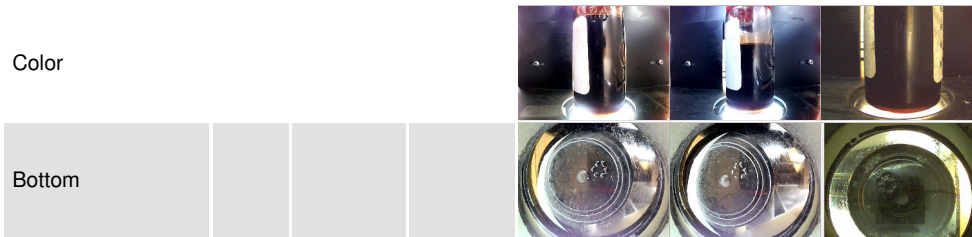
| SAMPLE IMAGES | method | limit/base | current | history1 | history2 |

| VISUAL | method | limit/base | current | history1 | history2 |
|---|---|---|---|---|---|
| Appearance | scalar | *Visual | NORML | NORML | NORML |

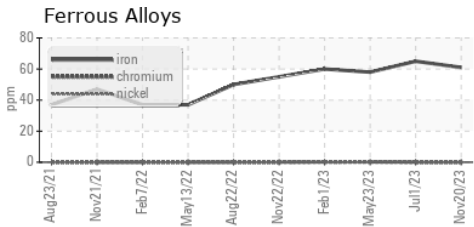
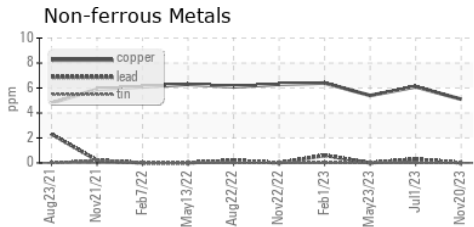
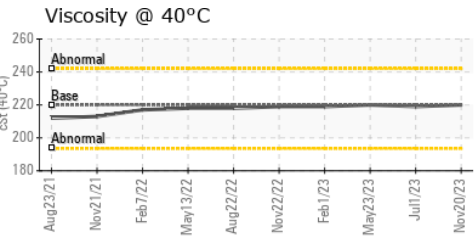
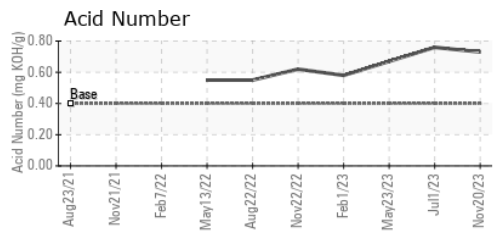
GRAPHS

All component wear rates are normal.

The AN level is acceptable for this fluid. The condition of the oil is suitable for further service.

Resample at the next service interval to monitor.
 NOTE: Please provide information regarding reservoir capacity, filter type and micron rating with next sample.
