OIL ANALYSIS REPORT

Machine Id
Abner Gap 2

Component
Compressor

Fluid
CITGO PACEMAKER GAS ENGIN 1700 SERIES 40W (26 GAL)

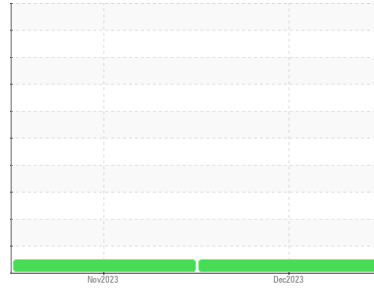
Sample Rating Trend

NORMAL

Resample at the next service interval to monitor.

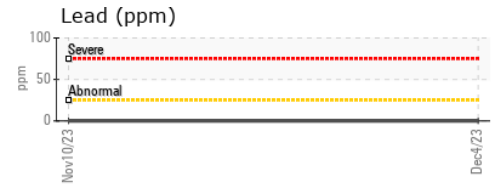
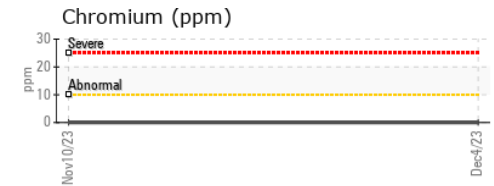
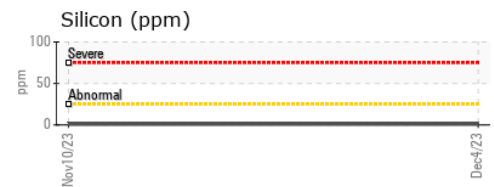
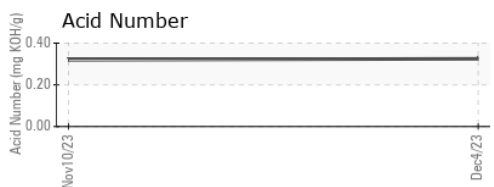
GRAPHS

All component wear rates are normal.

There is no indication of any contamination in the component.

The AN level is acceptable for this fluid. The condition of the oil is suitable for further service.
