OIL ANALYSIS REPORT

Area
KEMP QUARRIES / KEMP STONE - FAIRLAND [66087]
Machine Id
WL071
Component
Rear Differential
Fluid
PETRO CANADA PRODURO TO-4 SAE 50 (--- GAL)

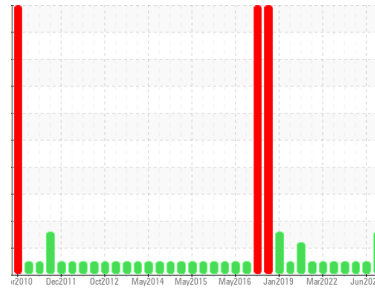
Sample Rating Trend

WATER

There is a moderate concentration of water present in the oil.

We advise that you check for the source of water entry. We recommend an early resample to monitor this condition. (Customer Sample Comment: PM-3 sampled fluid)

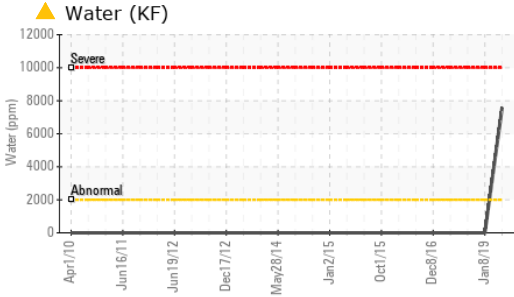
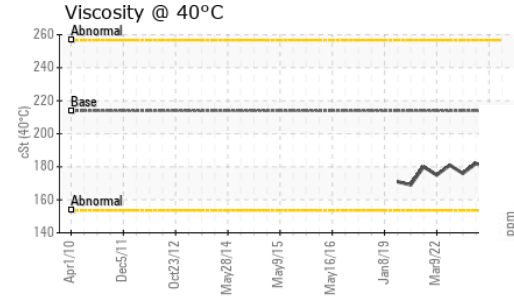
SAMPLE IMAGES		method	limit/base	current	history1	history2
---------------	--	--------	------------	---------	----------	----------

Color		no image	no image
Bottom		no image	no image
