Machine Id
928088-260340
 Component
Hydraulic System
 Fluid
NOT GIVEN (--- GAL)

Customer Id: GFL837
Sample No.: GFL0102531
Lab Number: 06035238
Test Package: FLEET

OIL ANALYSIS REPORT

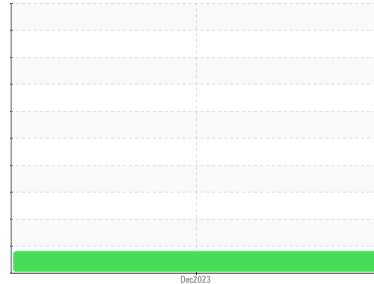
Sample Rating Trend

SEDIMENT

There is a moderate amount of visible silt present in the sample.

We recommend you service the filters on this component. Resample at the next service interval to monitor. We were unable to perform a particle count due to a high concentration of particles present in this sample.

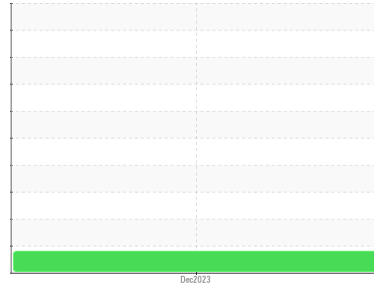
Sample Rating Trend

SEDIMENT

We recommend you service the filters on this component. Resample at the next service interval to monitor. We were unable to perform a particle count due to a high concentration of particles present in this sample.

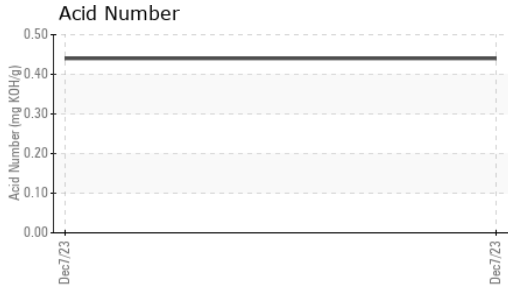
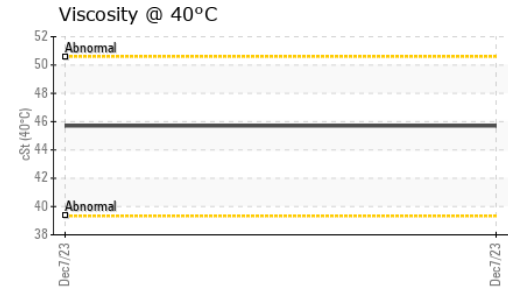
SAMPLE IMAGES

VISUAL	method	limit/base	current	history1	history2	
White Metal	scalar	*Visual	NONE	NONE	---	---
Yellow Metal	scalar	*Visual	NONE	NONE	---	---
Precipitate	scalar	*Visual	NONE	NONE	---	---
Silt	scalar	*Visual	NONE	▲ MODER	---	---
Debris	scalar	*Visual	NONE	NONE	---	---
Sand/Dirt	scalar	*Visual	NONE	NONE	---	---
Appearance	scalar	*Visual	NORML	NORML	---	---
Odor	scalar	*Visual	NORML	NORML	---	---
Emulsified Water	scalar	*Visual	>0.1	NEG	---	---
Free Water	scalar	*Visual		NEG	---	---
