# OIL ANALYSIS REPORT

Area  
**SCOF [98589725]**  
 Machine Id  
**VACUUM PUMP 1 (S/N SC10185647003)**  
 Component  
**Vacuum Pump**  
 Fluid  
**ISO 100 (--- QTS)**

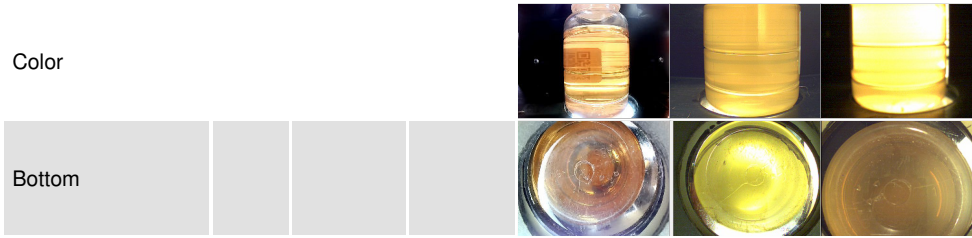
### SAMPLE IMAGES

The amount and size of particulates present in the system are acceptable. There is no indication of any contamination in the oil.

VISUAL		method	limit/base	current	history1	history2
White Metal	scalar	*Visual	NONE	<b>NONE</b>	NONE	NONE
Yellow Metal	scalar	*Visual	NONE	<b>NONE</b>	NONE	NONE
Precipitate	scalar	*Visual	NONE	<b>NONE</b>	NONE	NONE
Silt	scalar	*Visual	NONE	<b>NONE</b>	NONE	NONE
Debris	scalar	*Visual	NONE	<b>NONE</b>	NONE	NONE
Sand/Dirt	scalar	*Visual	NONE	<b>NONE</b>	NONE	NONE
Appearance	scalar	*Visual	NORML	<b>NORML</b>	NORML	NORML
Odor	scalar	*Visual	NORML	<b>NORML</b>	NORML	NORML
Emulsified Water	scalar	*Visual	>.1	<b>NEG</b>	NEG	NEG
Free Water	scalar	*Visual		<b>NEG</b>	NEG	NEG

Resample at the next service interval to monitor.

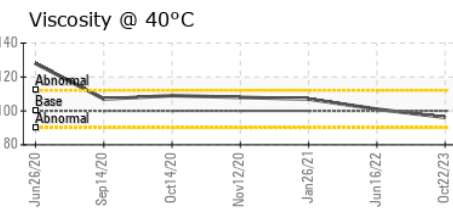
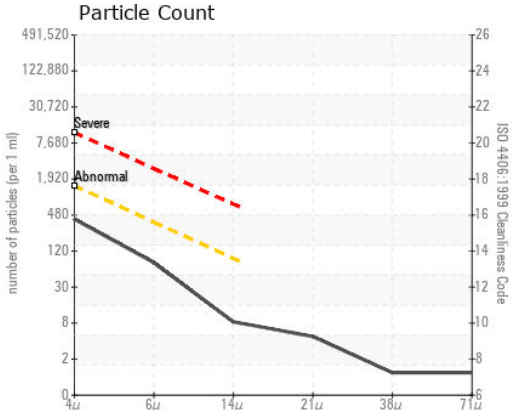
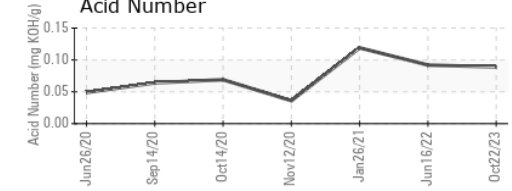
### GRAPHS

All component wear rates are normal.

The AN level is acceptable for this fluid. The condition of the oil is suitable for further service.
