OIL ANALYSIS REPORT

Area
KEMP QUARRIES / KEMP STONE - FAIRLAND [67743]
Machine Id
WL128
Component
Front Left Final Drive
Fluid
PETRO CANADA PRODURO TO-4 SAE 50 (--- GAL)

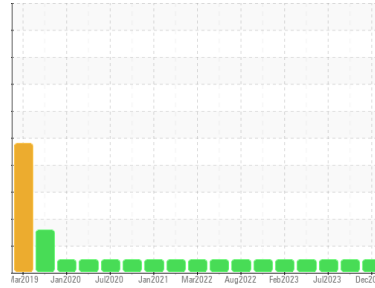
Sample Rating Trend

NORMAL

All component wear rates are normal.

There is no indication of any contamination in the oil.

The condition of the oil is acceptable for the time in service.

Resample at the next service interval to monitor. (Customer Sample Comment: PM-4 changed fluid)
