OIL ANALYSIS REPORT

Area
READY TO EAT [98664844]
 Machine Id
KR-GR-000255-EAST - CRUSTER DRIVE (S/N SLICE/5)
 Component
Gearbox
 Fluid
GEAR OIL ISO 220 (--- QTS)

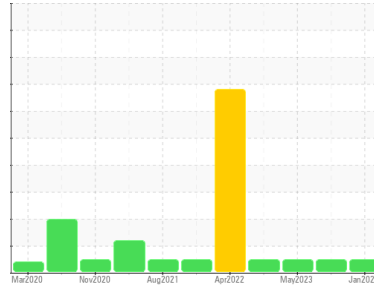
Sample Rating Trend

NORMAL

Resample at the next service interval to monitor. (Customer Sample Comment: 98664844)

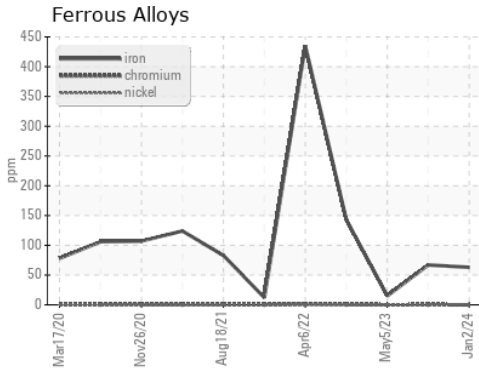
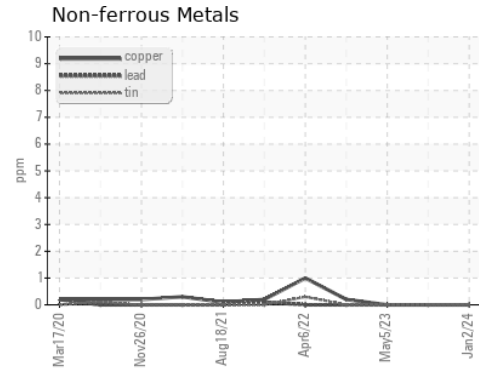
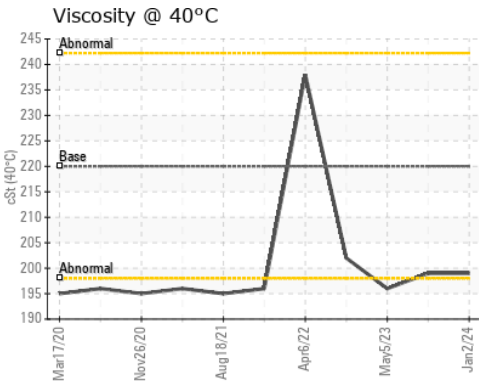
GRAPHS

All component wear rates are normal.

There is no indication of any contamination in the fluid.

The condition of the fluid is acceptable for the time in service.
