OIL ANALYSIS REPORT

Area
COOKHOUSE [98676528]
 Machine Id
KR-GR-000236 (S/N COOKHOUSE 2 - 11525948)
 Component
Gearbox
 Fluid
GEAR OIL ISO 460 (--- GAL)

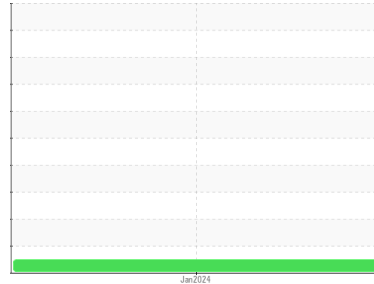
Sample Rating Trend

NORMAL

Wear
 All component wear rates are normal.

Contamination
 There is no indication of any contamination in the oil.

Fluid Condition
 The condition of the oil is acceptable for the time in service.

Recommendation
 Resample at the next service interval to monitor. (Customer Sample Comment: 98676528)
