OIL ANALYSIS REPORT

Area
KEMP QUARRIES / HULBERT
Machine Id
OHT047
Component
Rear Left Final Drive
Fluid
MOBIL MOBILTRANS HD 50 (--- GAL)

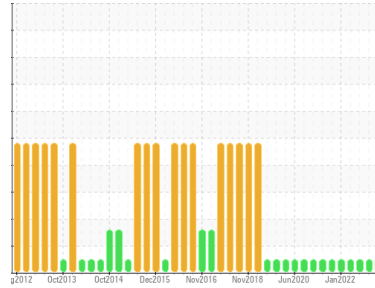
Sample Rating Trend

NORMAL

All component wear rates are normal.

There is no indication of any contamination in the oil.

The condition of the oil is acceptable for the time in service.

Resample at the next service interval to monitor.
