OIL ANALYSIS REPORT

Area
KEMP QUARRIES / RIVER VALLEY BACKBONE
Machine Id
WL088
Component
Front Differential
Fluid
MOBIL MOBILTRANS HD 50 (--- GAL)

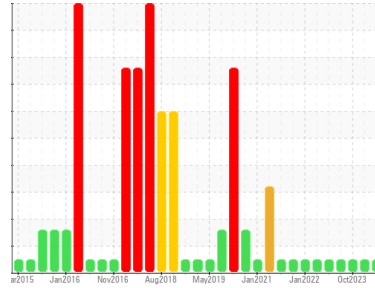
Sample Rating Trend

NORMAL

All component wear rates are normal.

There is no indication of any contamination in the oil.

The condition of the oil is acceptable for the time in service.

Resample at the next service interval to monitor.
