OIL ANALYSIS REPORT

Area
KEMP QUARRIES / RIVER VALLEY BACKBONE
Machine Id
WL088
Component
Hydraulic System
Fluid
MOBIL DELVAC 1300 SUPER15W40 (--- GAL)

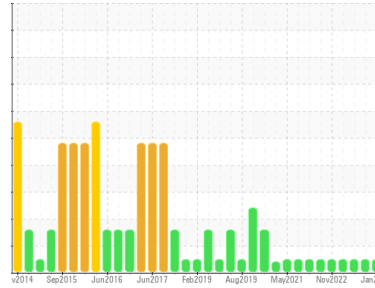
Sample Rating Trend

NORMAL

All component wear rates are normal.

There is no indication of any contamination in the fluid.

The condition of the fluid is acceptable for the time in service.

Resample at the next service interval to monitor.
