OIL ANALYSIS REPORT

Area
KEMP QUARRIES / PRYOR STONE [67030]
 Machine Id
MLIFT003
 Component
Hydraulic System
 Fluid
PETRO CANADA HYDREX AW 68 (--- GAL)

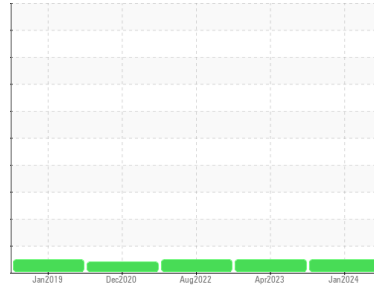
Sample Rating Trend

NORMAL

All component wear rates are normal.

There is no indication of any contamination in the oil.

The condition of the oil is acceptable for the time in service.

Resample at the next service interval to monitor. (Customer Sample Comment: Pm4 performed. All oil samples taken. All oils, and all filters changed.)
