OIL ANALYSIS REPORT

730

Rear Differential

JOHN DEERE HY-GARD HYDRAULIC/RANSMISSION (--- GAL)

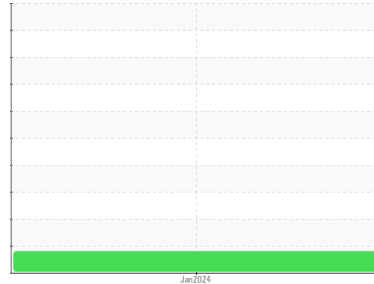
Sample Rating Trend

Bearing and/or bushing wear is indicated. All other component wear rates are normal.

| | method | limit/base | current | history1 | history2 |
|---|---|---|---|---|---|
| Lead | ppm | ASTM D5185m >25 | ▲ 71 | --- | --- |

No corrective action is recommended at this time. Resample at the next service interval to monitor.
