OIL ANALYSIS REPORT

Area
KEMP QUARRIES / BCS - GRAVETTE [68011]
Machine Id
OHT107
Component
Hydraulic System
Fluid
PETRO CANADA HYDREX AW 68 (--- GAL)

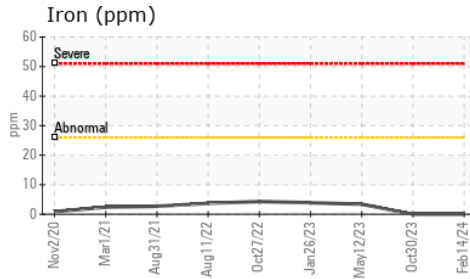
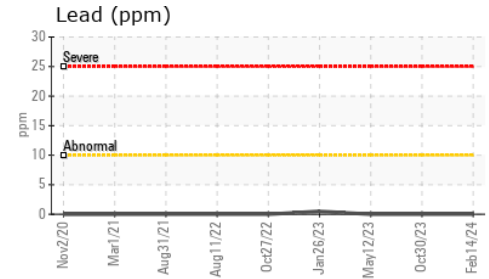
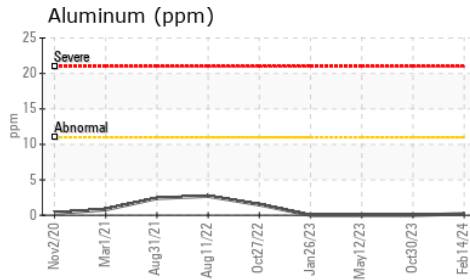
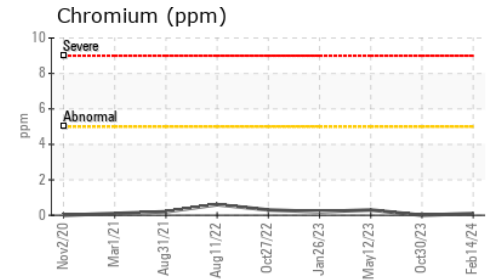
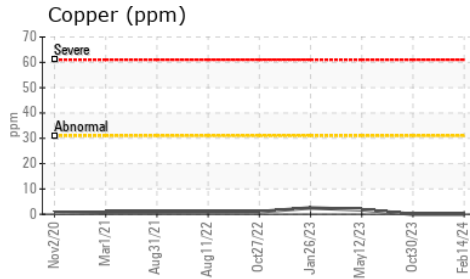
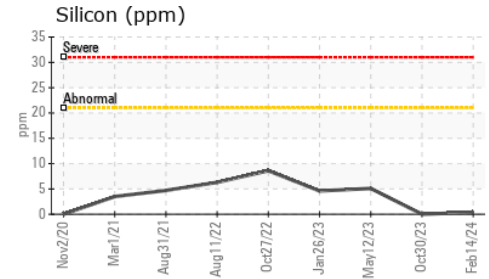
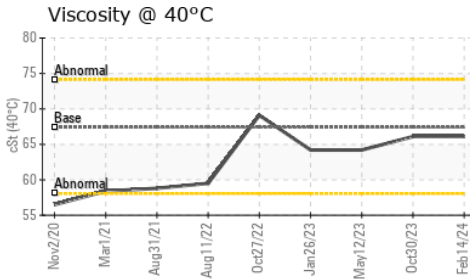
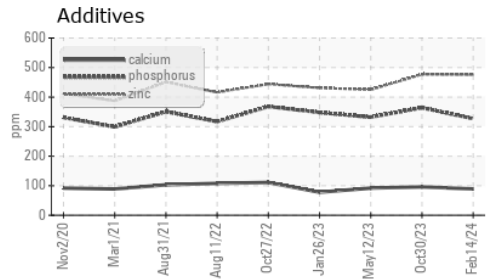
GRAPHS

All component wear rates are normal.

There is no indication of any contamination in the fluid.

The condition of the fluid is acceptable for the time in service.

Resample at the next service interval to monitor. (Customer Sample Comment: Pm4)
