OIL ANALYSIS REPORT

VOLVO 26553

Hydraulic System

AW HYDRAULIC OIL ISO 46 (--- GAL)

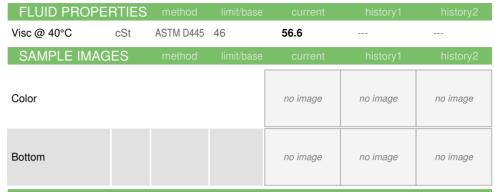
GRAPHS

All component wear rates are normal.

There is no indication of any contamination in the oil.

The condition of the oil is acceptable for the time in service.

Resample at the next service interval to monitor. Please specify the brand, type, and viscosity of the oil on your next sample.
