# PROBLEM SUMMARY

Area  
**[908106644]**  
 Machine Id  
**TANK 35 TANK 35**  
 Component  
**Agitator Gearbox**  
 Fluid  
**COMP OIL (POE) ISO 220 (4 Oz)**

# OIL ANALYSIS REPORT

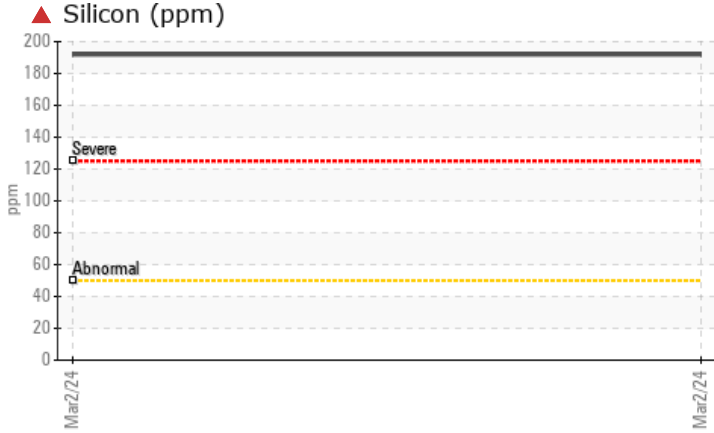
## COMPONENT CONDITION SUMMARY

**Contamination**  
 Elemental level of silicon (Si) above normal indicating ingress of dirt/seal material.

**Recommendation**  
 We advise that you check all areas where dirt can enter the system. We recommend an early resample to monitor this condition.

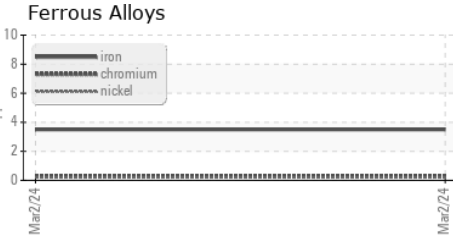
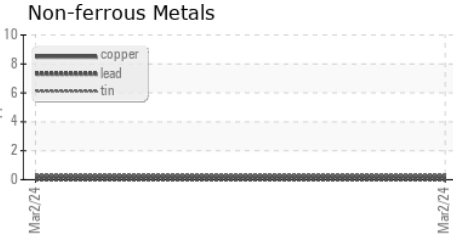
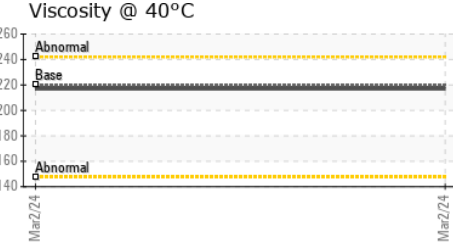
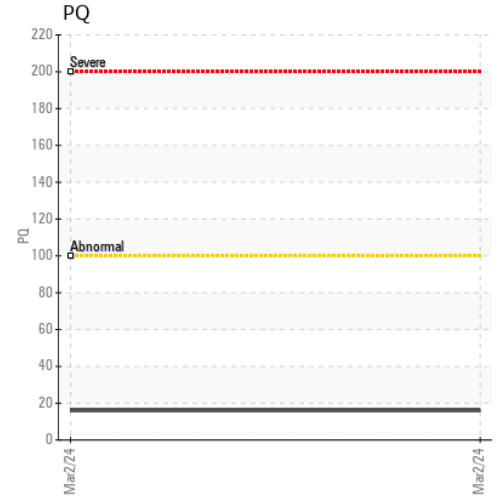
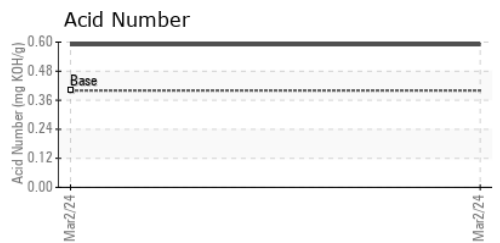
## GRAPHS

method	limit/base	current	history1	history2
Silicon	ppm	ASTM D5185m >50	<b>▲ 192</b>	---	---
Sodium	ppm	ASTM D5185m	<b>0</b>	---	---
Potassium	ppm	ASTM D5185m >20	<b>&lt;1</b>	---	---
