OIL ANALYSIS REPORT

Area
KEMP QUARRIES / KEMP STONE - FAIRLAND [68775]
Machine Id
WL086
Component
Hydraulic System
Fluid
PETRO CANADA HYDREX AW 68 (--- GAL)

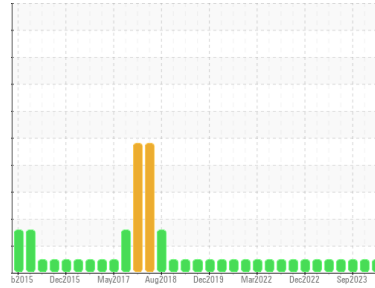
Sample Rating Trend

NORMAL

All component wear rates are normal.

There is no indication of any contamination in the fluid.

The condition of the fluid is acceptable for the time in service.

Resample at the next service interval to monitor. (Customer Sample Comment: PM-3 sampled fluid)
