# OIL ANALYSIS REPORT

Area  
**KEMP QUARRIES / PRYOR STONE [64441]**  
 Machine Id  
**WL103**  
 Component  
**Rear Differential**  
 Fluid  
**PETRO CANADA PRODURO TO-4 SAE 50 (--- GAL)**

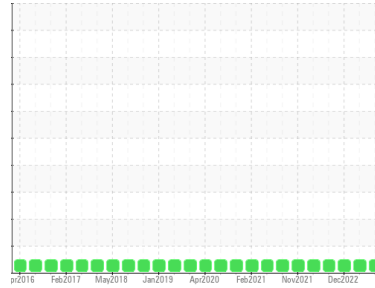
Sample Rating Trend

**NORMAL**

All component wear rates are normal.

There is no indication of any contamination in the oil.

The condition of the oil is acceptable for the time in service.

Resample at the next service interval to monitor. ( Customer Sample Comment: Pm4 performed. All oil samples taken. Engine oil, transmission oil, and all filters changed. )
