OIL ANALYSIS REPORT

Area
KEMP QUARRIES / PRYOR STONE [68434]
Machine Id
OHT085
Component
Hydraulic System
Fluid
PETRO CANADA HYDREX AW 68 (--- GAL)

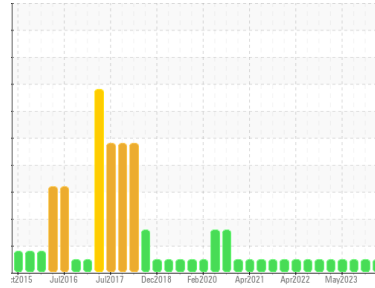
Sample Rating Trend

NORMAL

All component wear rates are normal.

There is no indication of any contamination in the oil.

The condition of the oil is acceptable for the time in service.

Resample at the next service interval to monitor. (Customer Sample Comment: Pm1 performed. All oil samples taken. Engine oil, engine oil filters, fuel, air, and cabin air filters changed.)
