# OIL ANALYSIS REPORT

**MIX ROOM D [98763417]**

**KR-GR-003114 - EAST DUMPER (S/N MIX D - 11513073)**

**Hydraulic System**

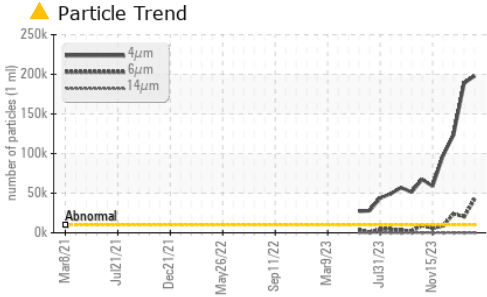
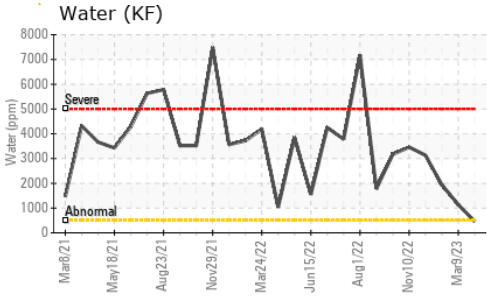
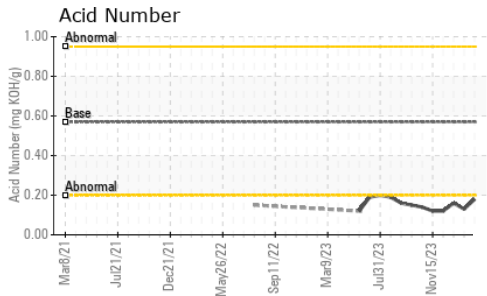
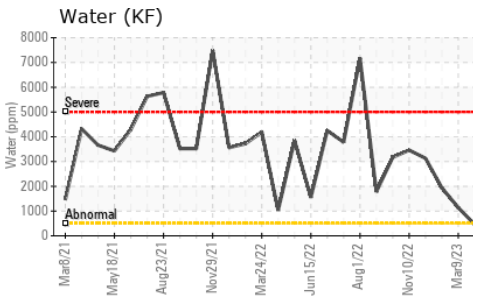
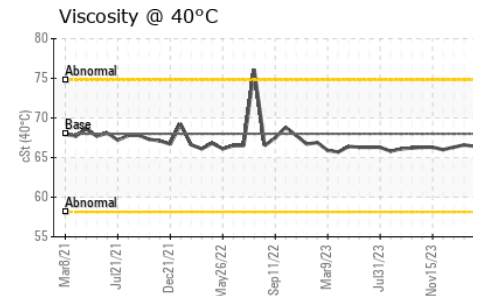
There is a high amount of silt (particulates < 14 microns in size) present in the oil.

FLUID CLEANLINESS		method	limit/base	current	history1	history2
Particles >4µm		ASTM D7647	>10000	<b>▲ 198107</b>	▲ 188767	▲ 123688
Particles >6µm		ASTM D7647	>2500	<b>▲ 42614</b>	▲ 20199	▲ 24079
Particles >14µm		ASTM D7647	>640	<b>148</b>	117	75
Particles >21µm		ASTM D7647	>160	<b>8</b>	22	10
Particles >38µm		ASTM D7647	>40	<b>0</b>	1	0
Particles >71µm		ASTM D7647	>10	<b>0</b>	0	0
Oil Cleanliness		ISO 4406 (c)	>20/18/16	<b>▲ 25/23/14</b>	▲ 25/22/14	▲ 24/22/13

We recommend you service the filters on this component if applicable. Resample at the next service interval to monitor. ( Customer Sample Comment: 98763417 )

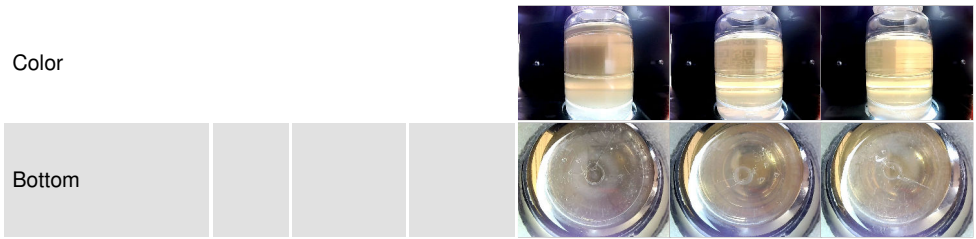
SAMPLE IMAGES	method	limit/base	current	history1	history2
---------------	--------	------------	---------	----------	----------

VISUAL	method	limit/base	current	history1	history2
White Metal	scalar	*Visual	NONE	NONE	NONE
Yellow Metal	scalar	*Visual	NONE	NONE	NONE
Precipitate	scalar	*Visual	NONE	NONE	NONE
Silt	scalar	*Visual	NONE	NONE	NONE
Debris	scalar	*Visual	NONE	NONE	NONE
Sand/Dirt	scalar	*Visual	NONE	NONE	NONE
Appearance	scalar	*Visual	NORML	NORML	NORML
Odor	scalar	*Visual	NORML	NORML	NORML
Emulsified Water	scalar	*Visual	>0.05	0.2%	NEG
Free Water	scalar	*Visual		NEG	NEG
