OIL ANALYSIS REPORT

Machine Id
738672
 Component
Diesel Engine
 Fluid
PETRO CANADA DURON SHP 10W30 (--- GAL)

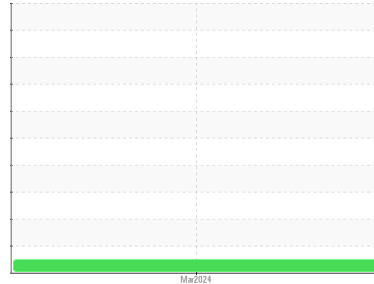
Sample Rating Trend

NORMAL

All component wear rates are normal.

There is no indication of any contamination in the oil.

The BN result indicates that there is suitable alkalinity remaining in the oil. The condition of the oil is acceptable for the time in service.

Resample at the next service interval to monitor.
