OIL ANALYSIS REPORT

Area
KEMP QUARRIES / RIVER VALLEY OZARK
 Machine Id
WL091
 Component
Front Left Final Drive
 Fluid
MOBIL MOBILTRANS HD 50 (--- GAL)

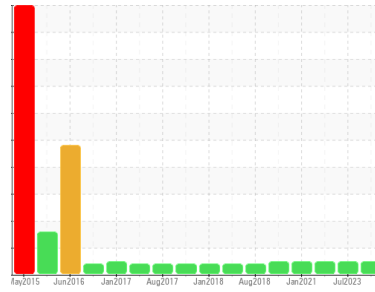
Sample Rating Trend

Wear
 Gear wear is indicated.

Contamination
 There is no indication of any contamination in the oil.

Fluid Condition
 The condition of the oil is acceptable for the time in service.

Recommendation
 No corrective action is recommended at this time. Resample at the next service interval to monitor.

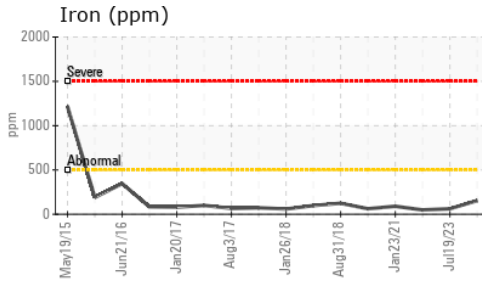
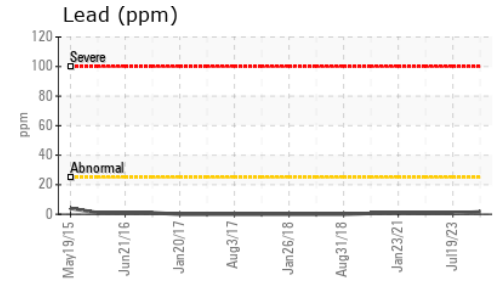
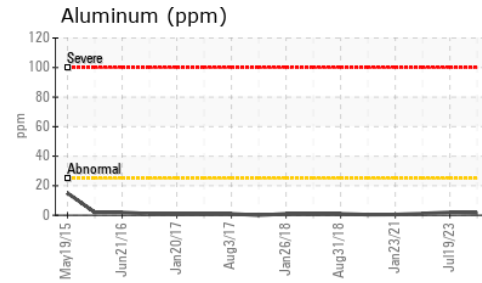
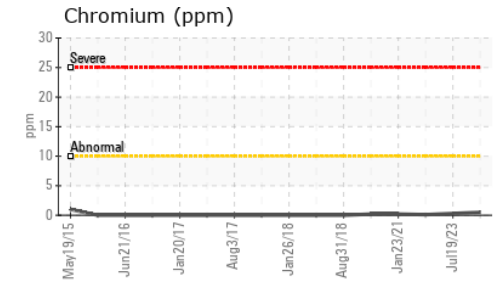
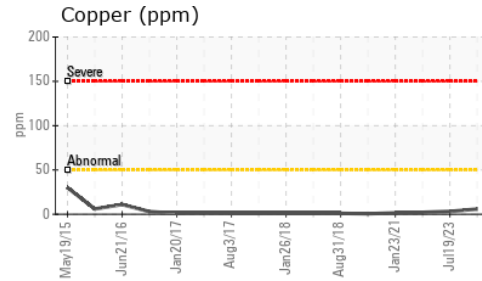
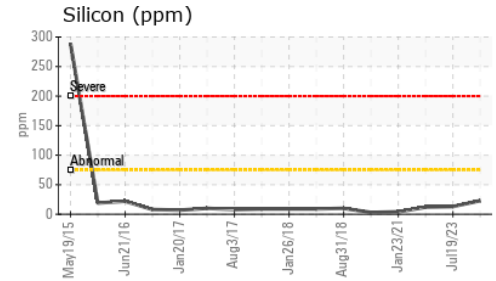
GRAPHS

method	limit/base	current	history1	history2
Iron	ppm	ASTM D5185m >500	154	62	49
Chromium	ppm	ASTM D5185m >10	<1	<1	<1
Nickel	ppm	ASTM D5185m >10	<1	0	0
Titanium	ppm	ASTM D5185m	<1	<1	<1
Silver	ppm	ASTM D5185m	0	0	0
Aluminum	ppm	ASTM D5185m >25	2	2	1
Lead	ppm	ASTM D5185m >25	2	<1	<1
Copper	ppm	ASTM D5185m >50	6	3	2
Tin	ppm	ASTM D5185m >10	<1	<1	0
Antimony	ppm	ASTM D5185m >5	---	---	---
Vanadium	ppm	ASTM D5185m	0	0	0
Cadmium	ppm	ASTM D5185m	<1	0	0
